The Flixborough disaster

Report of the Court of Inquiry

**Formal Investigation into Accident on 1st June
1974 at the Nypro Factory at Flixborough**

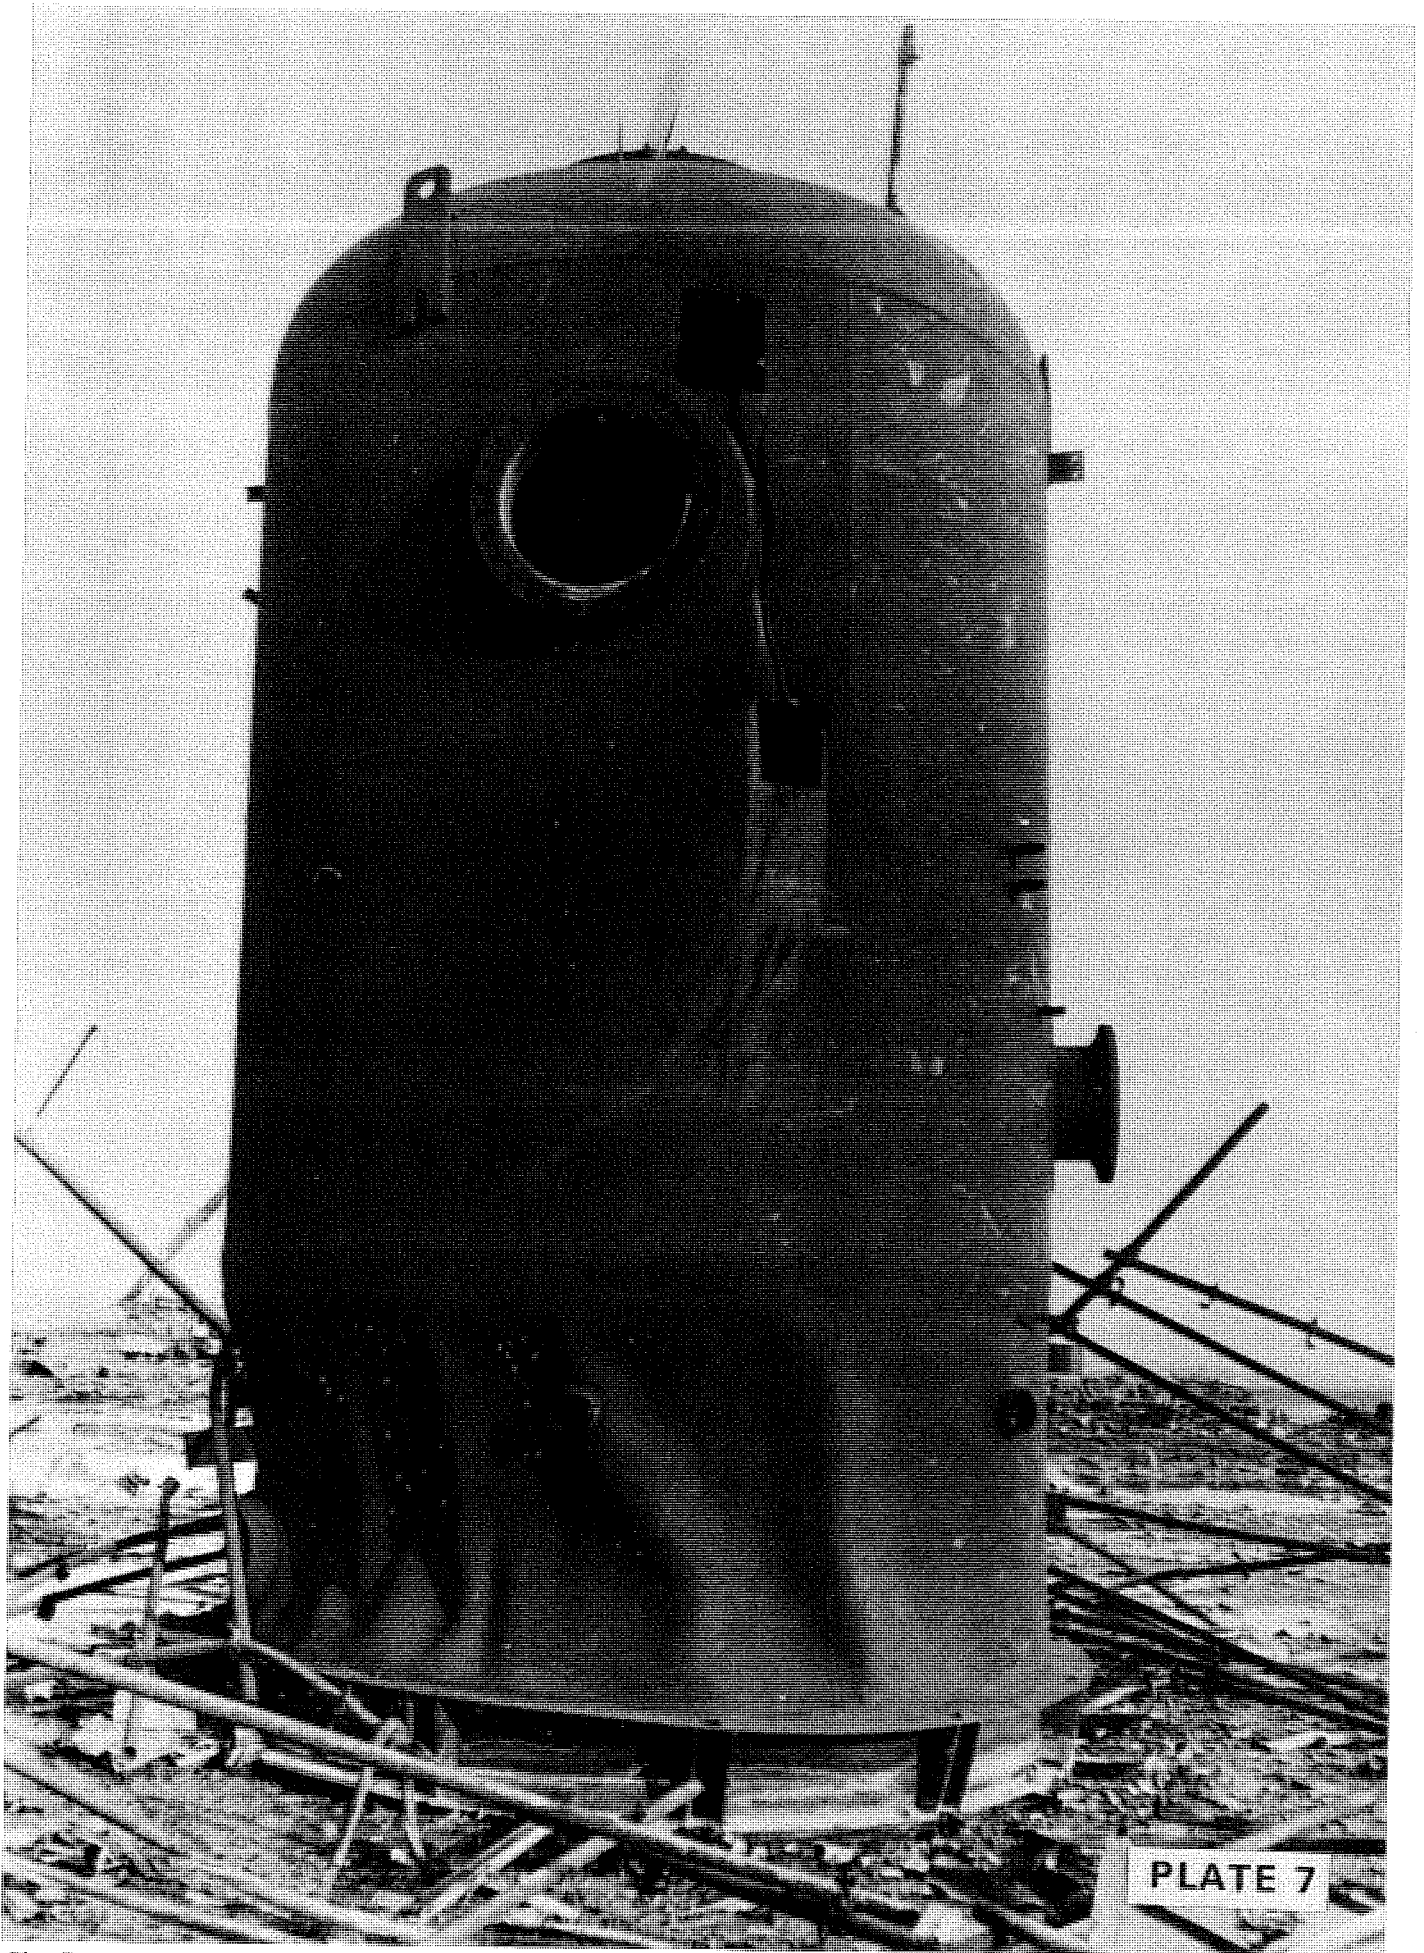
53 In the evening of 27th March, cyclohexane was discovered to be leaking from Reactor No. 5 (R2525) which like the other reactors, was constructed of $\frac{1}{2}$ inch mild steel plate with $\frac{1}{8}$ inch stainless steel bonded to it. On investigation a vertical crack was found in the mild steel outer layer of the reactor shell (Plate 7) and cyclohexane was emerging over a small part of this crack thus indicating that the inner stainless steel layer was also defective. The Chief Superintendent on duty telephoned the Plant Manager for Area 2 and it was agreed between them that the plant should be shut down, depressurised and cooled when a full inspection might take place.

54 The following morning, the 28th March, the Plant Manager inspected the crack, and found that it extended for some 6 feet. This was clearly a serious state of affairs and the same morning a meeting was held to decide what should be done. It was attended by Mr Beckers the General Works Manager,

Plate 7 Reactor 5 showing crack which led to its removal and replacement by the by-pass in March 1974. The square holes are where metal has been removed for examination (crack opened by fire).

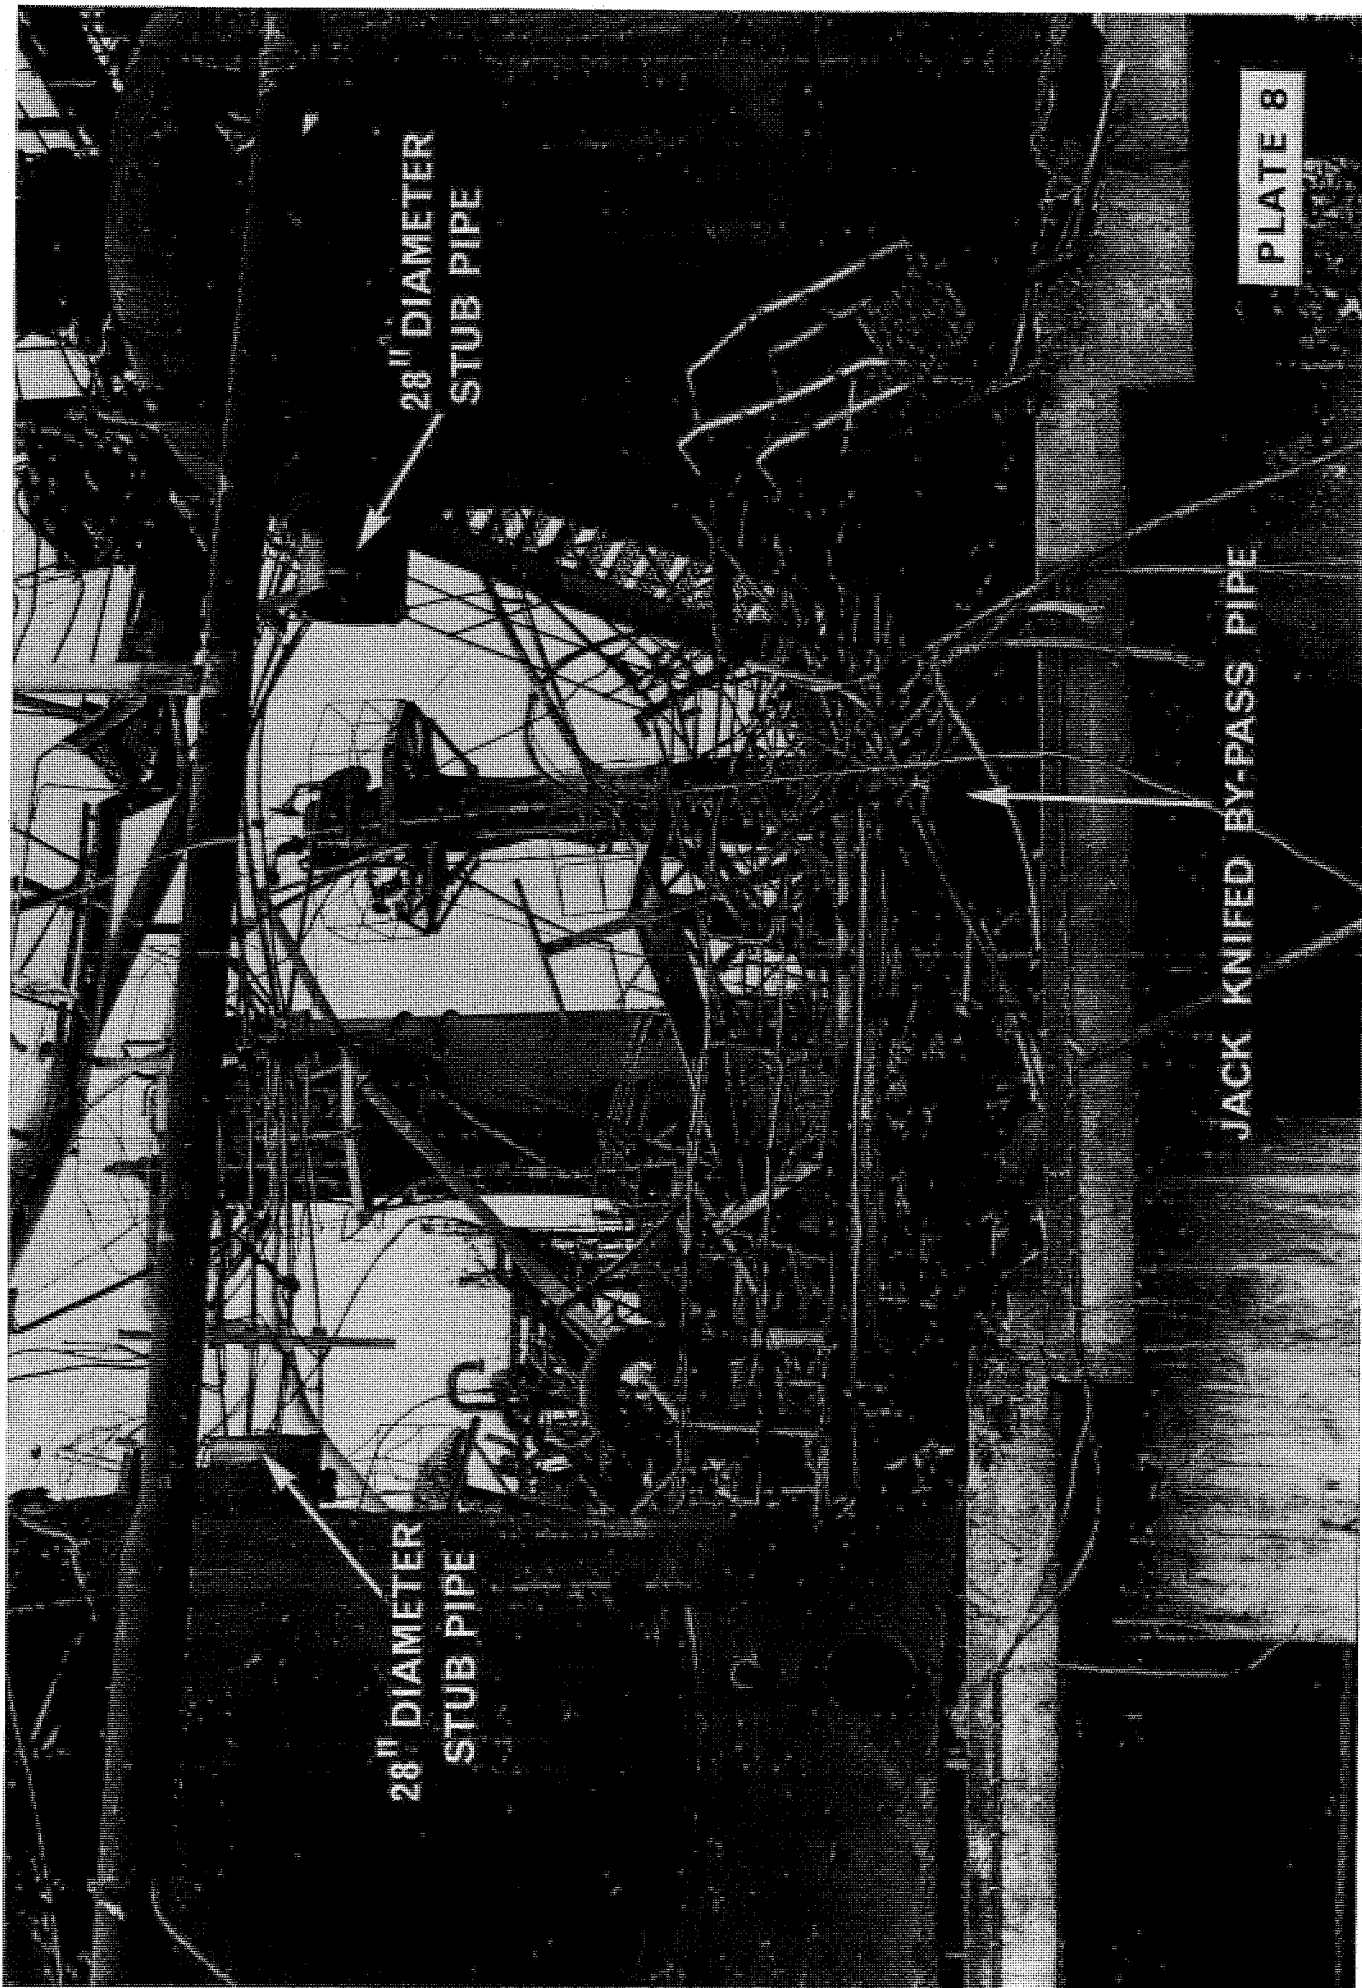
Plate 8 Reactors 4 and 6 soon after the explosion.

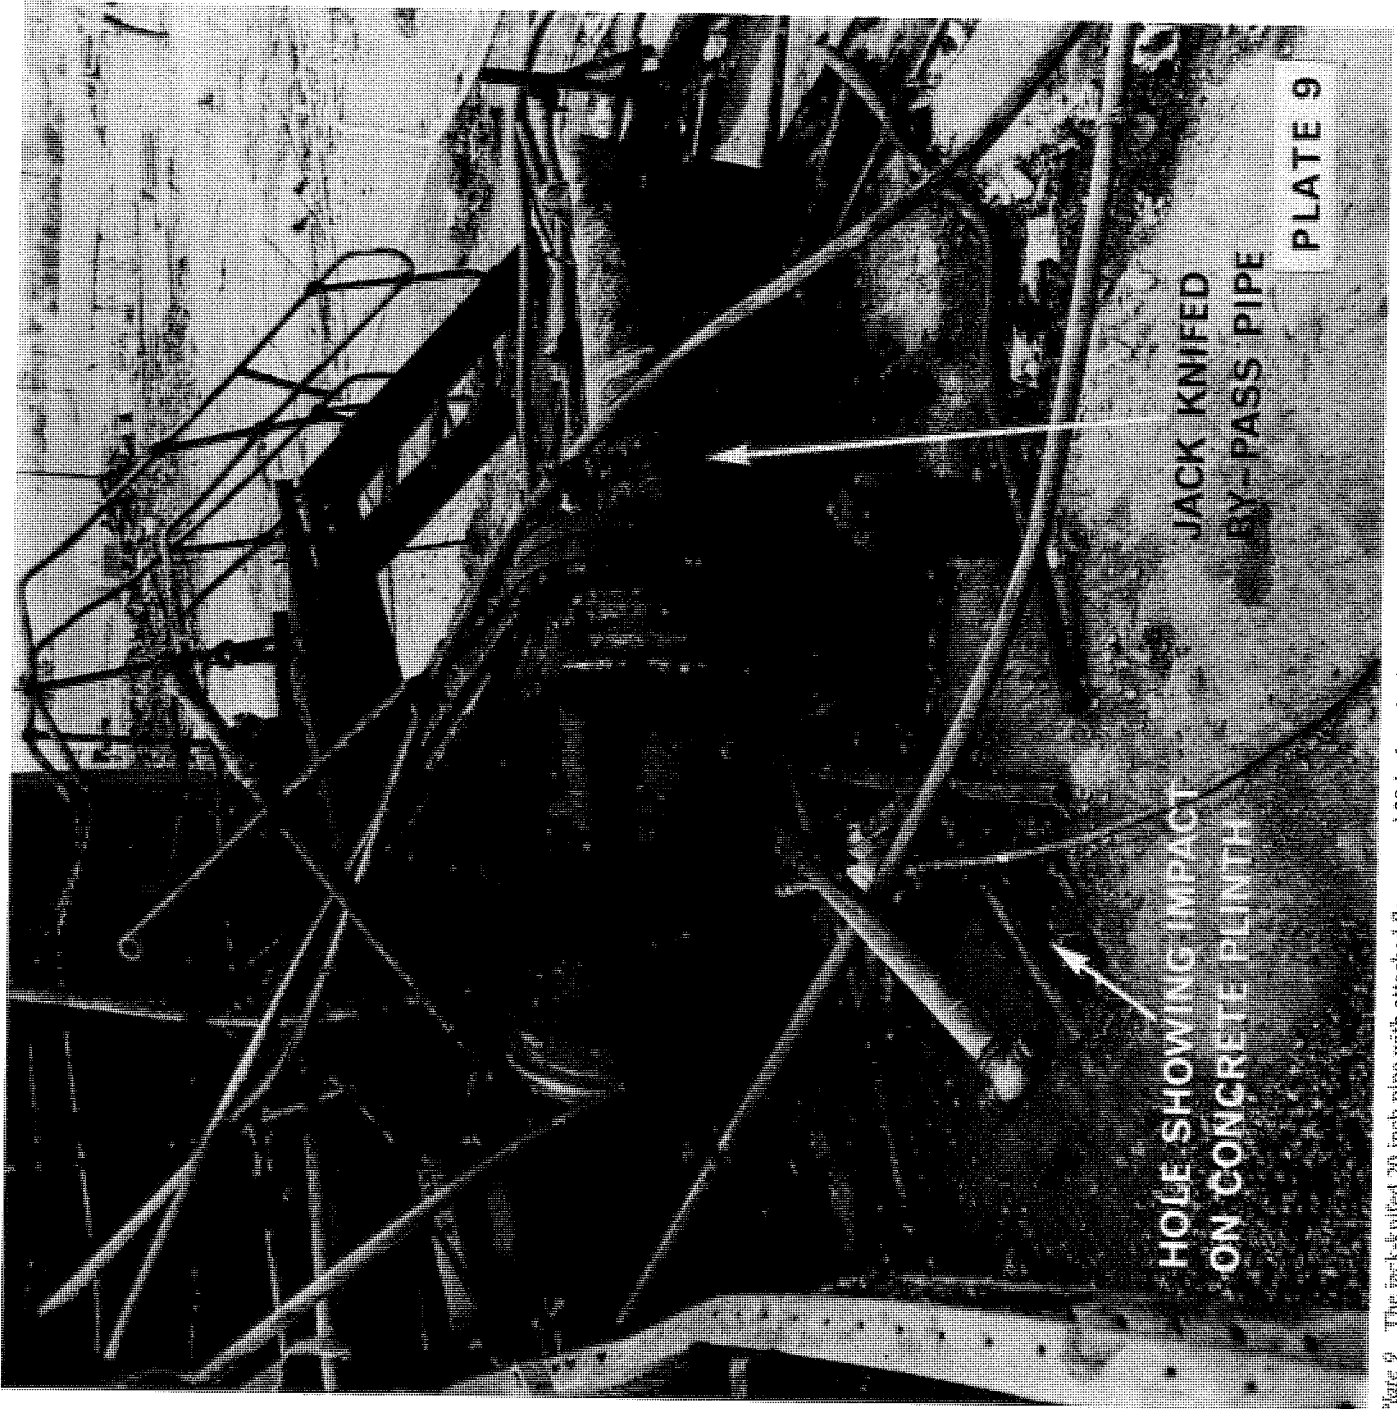
Plate 9 The jack-knifed 20 inch pipe with attached flanges and 28 inch stub pipes.

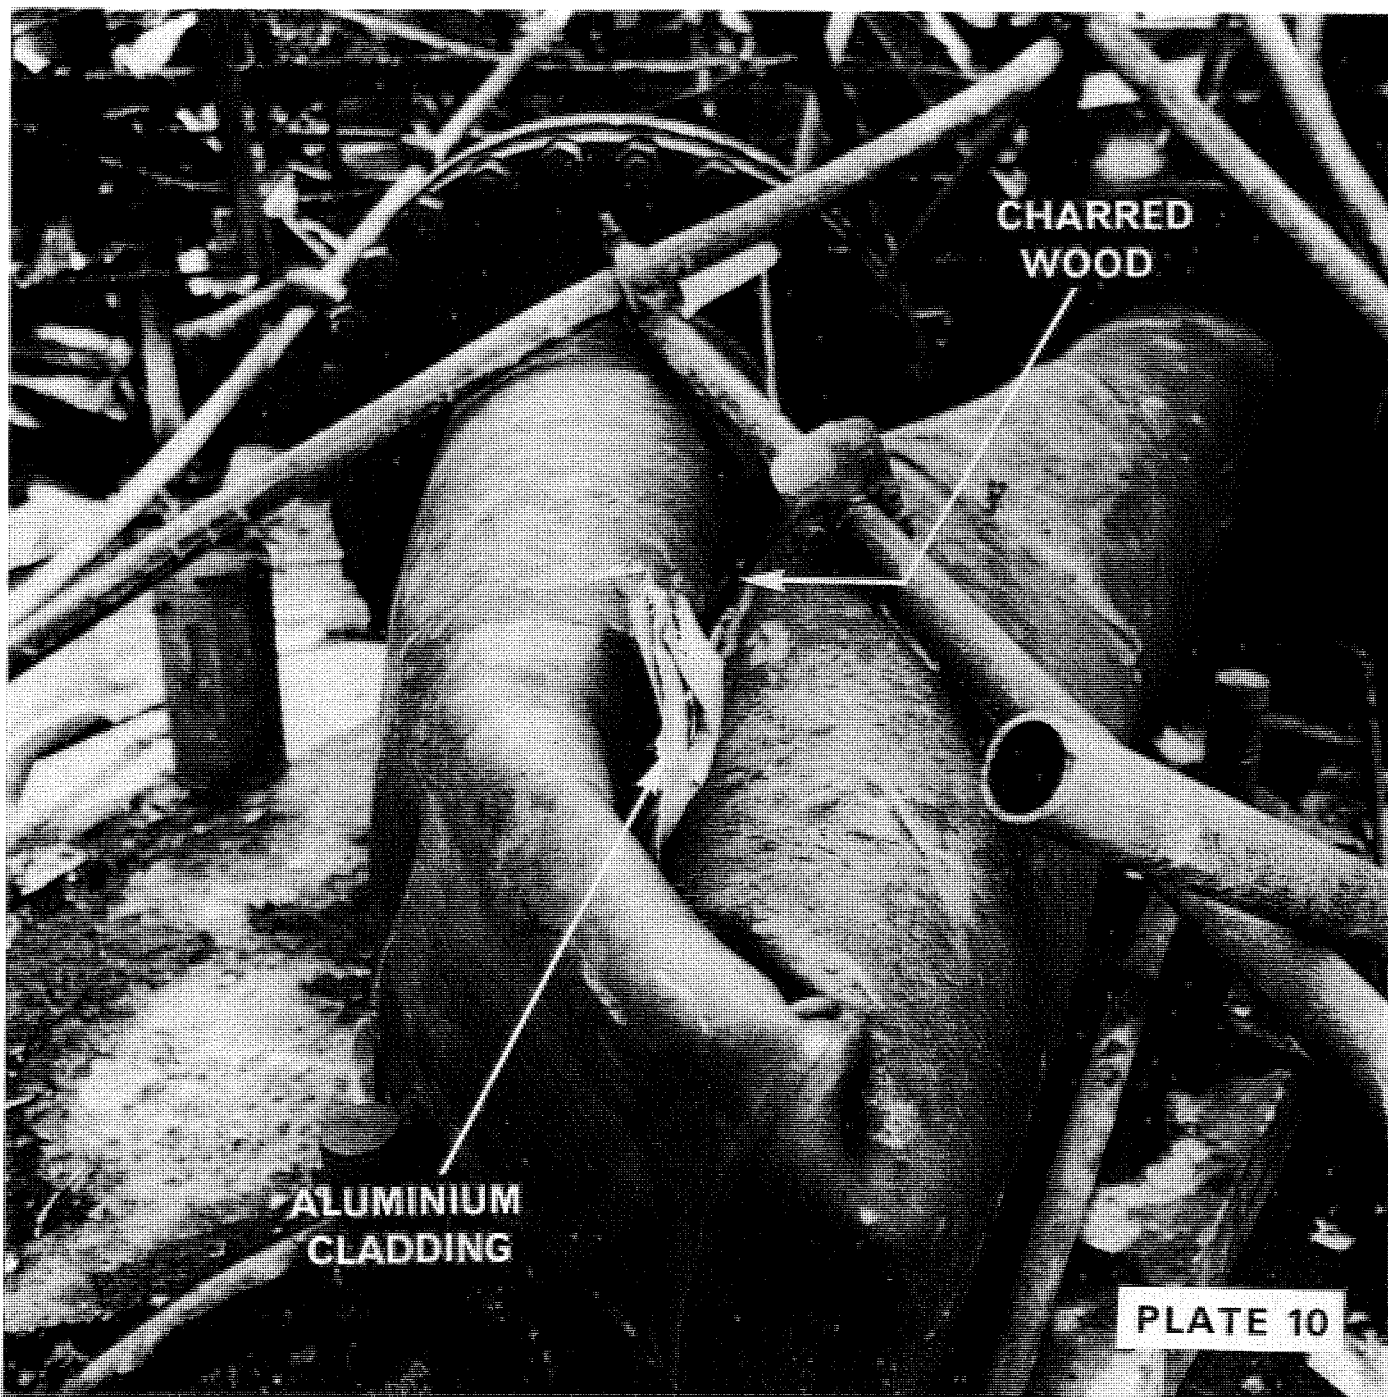
Plate 10 The jack-knifed 20 inch pipe showing trapped aluminium cladding and charred wood.

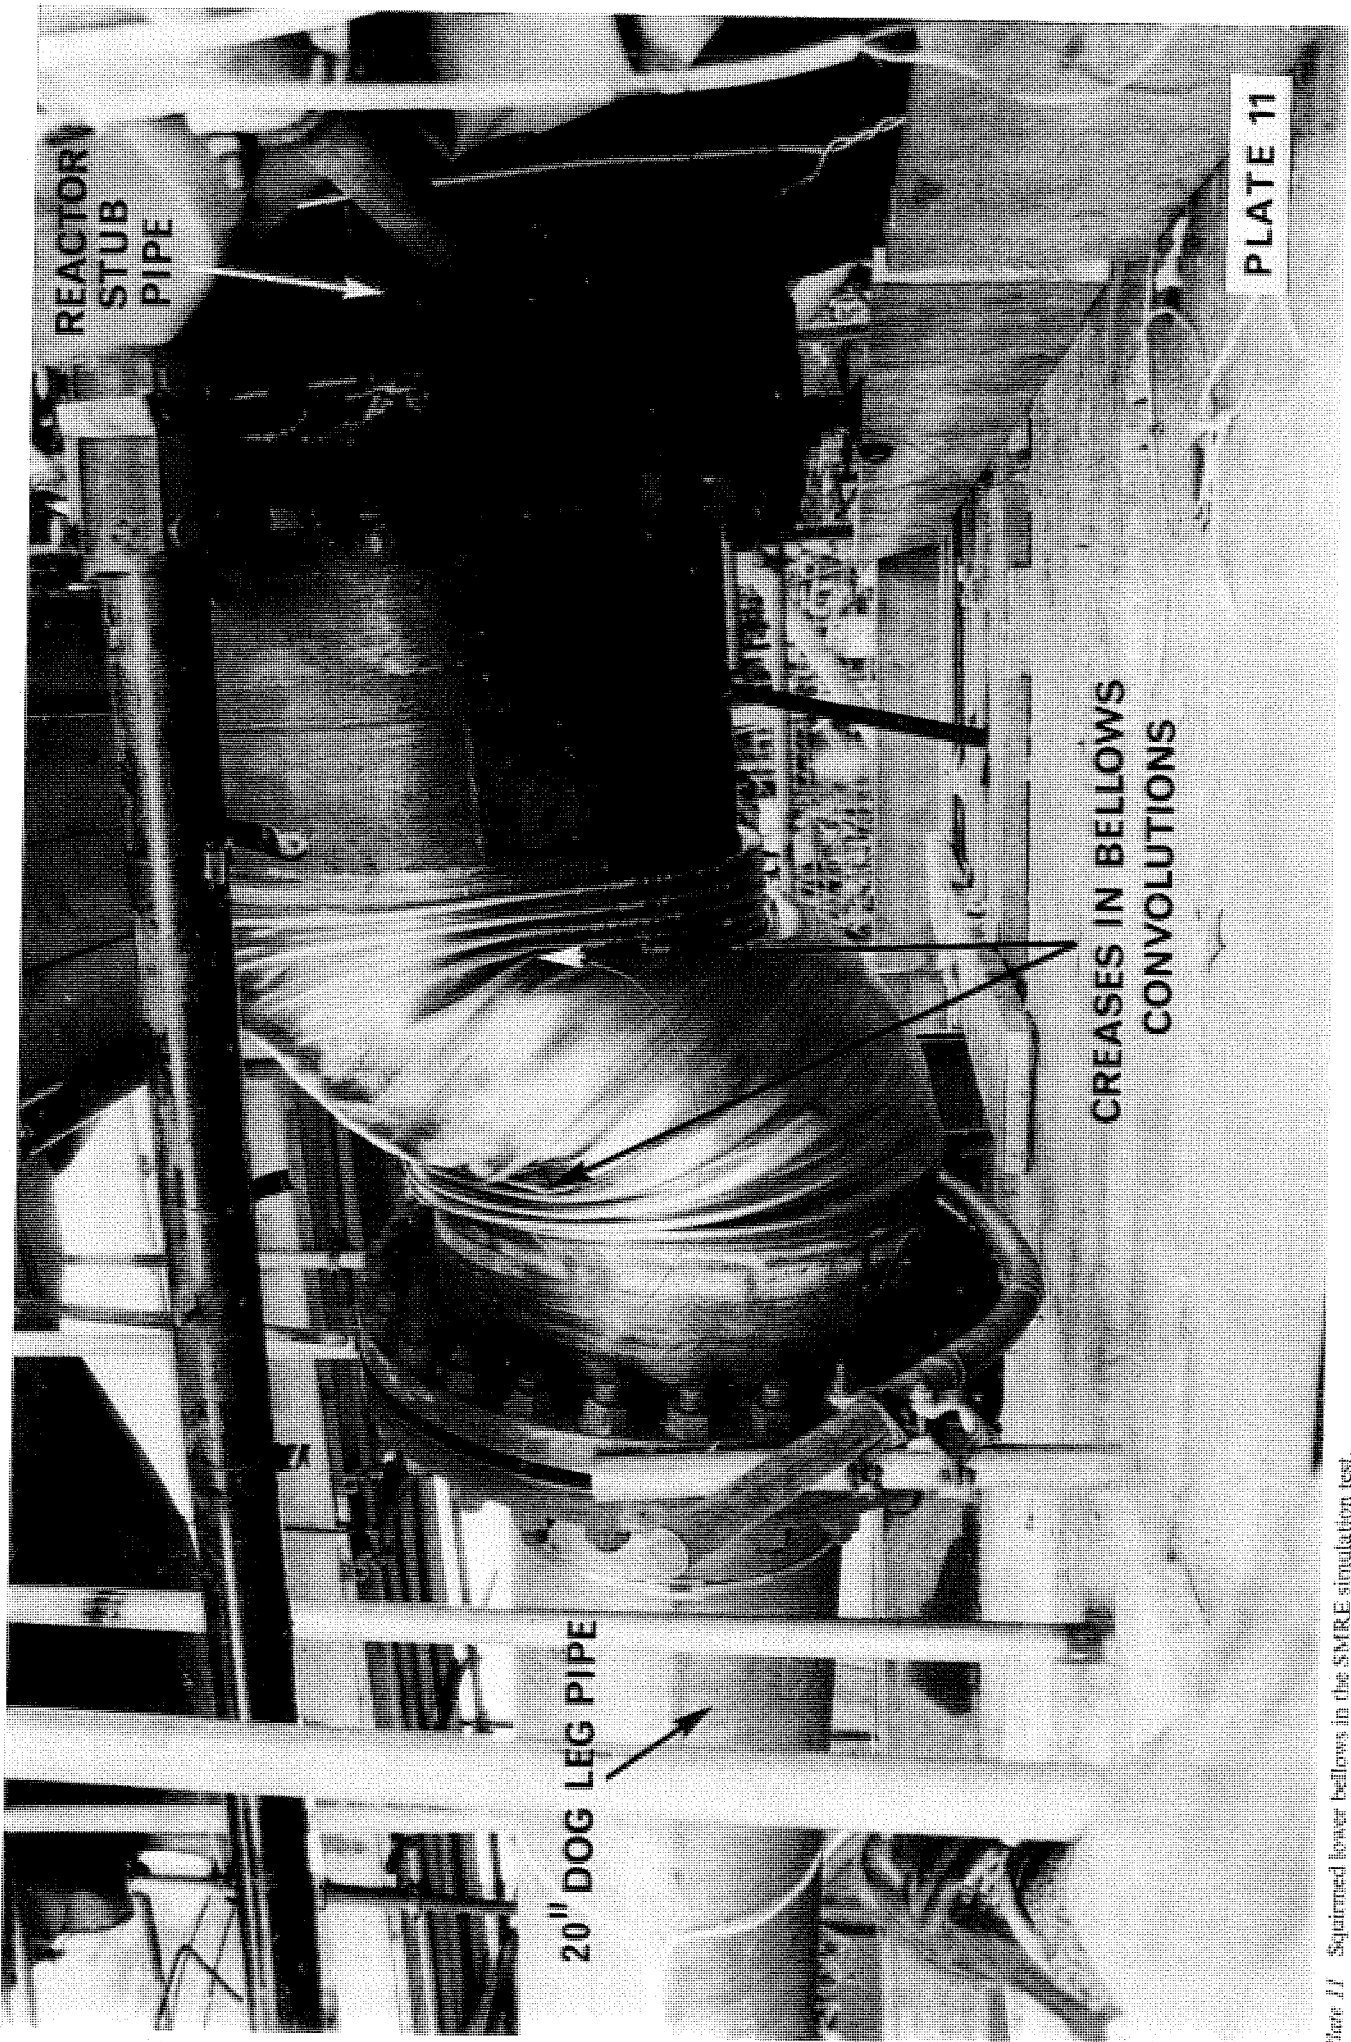
Plate 11 Squirmed lower bellows in the SMRE simulation test.

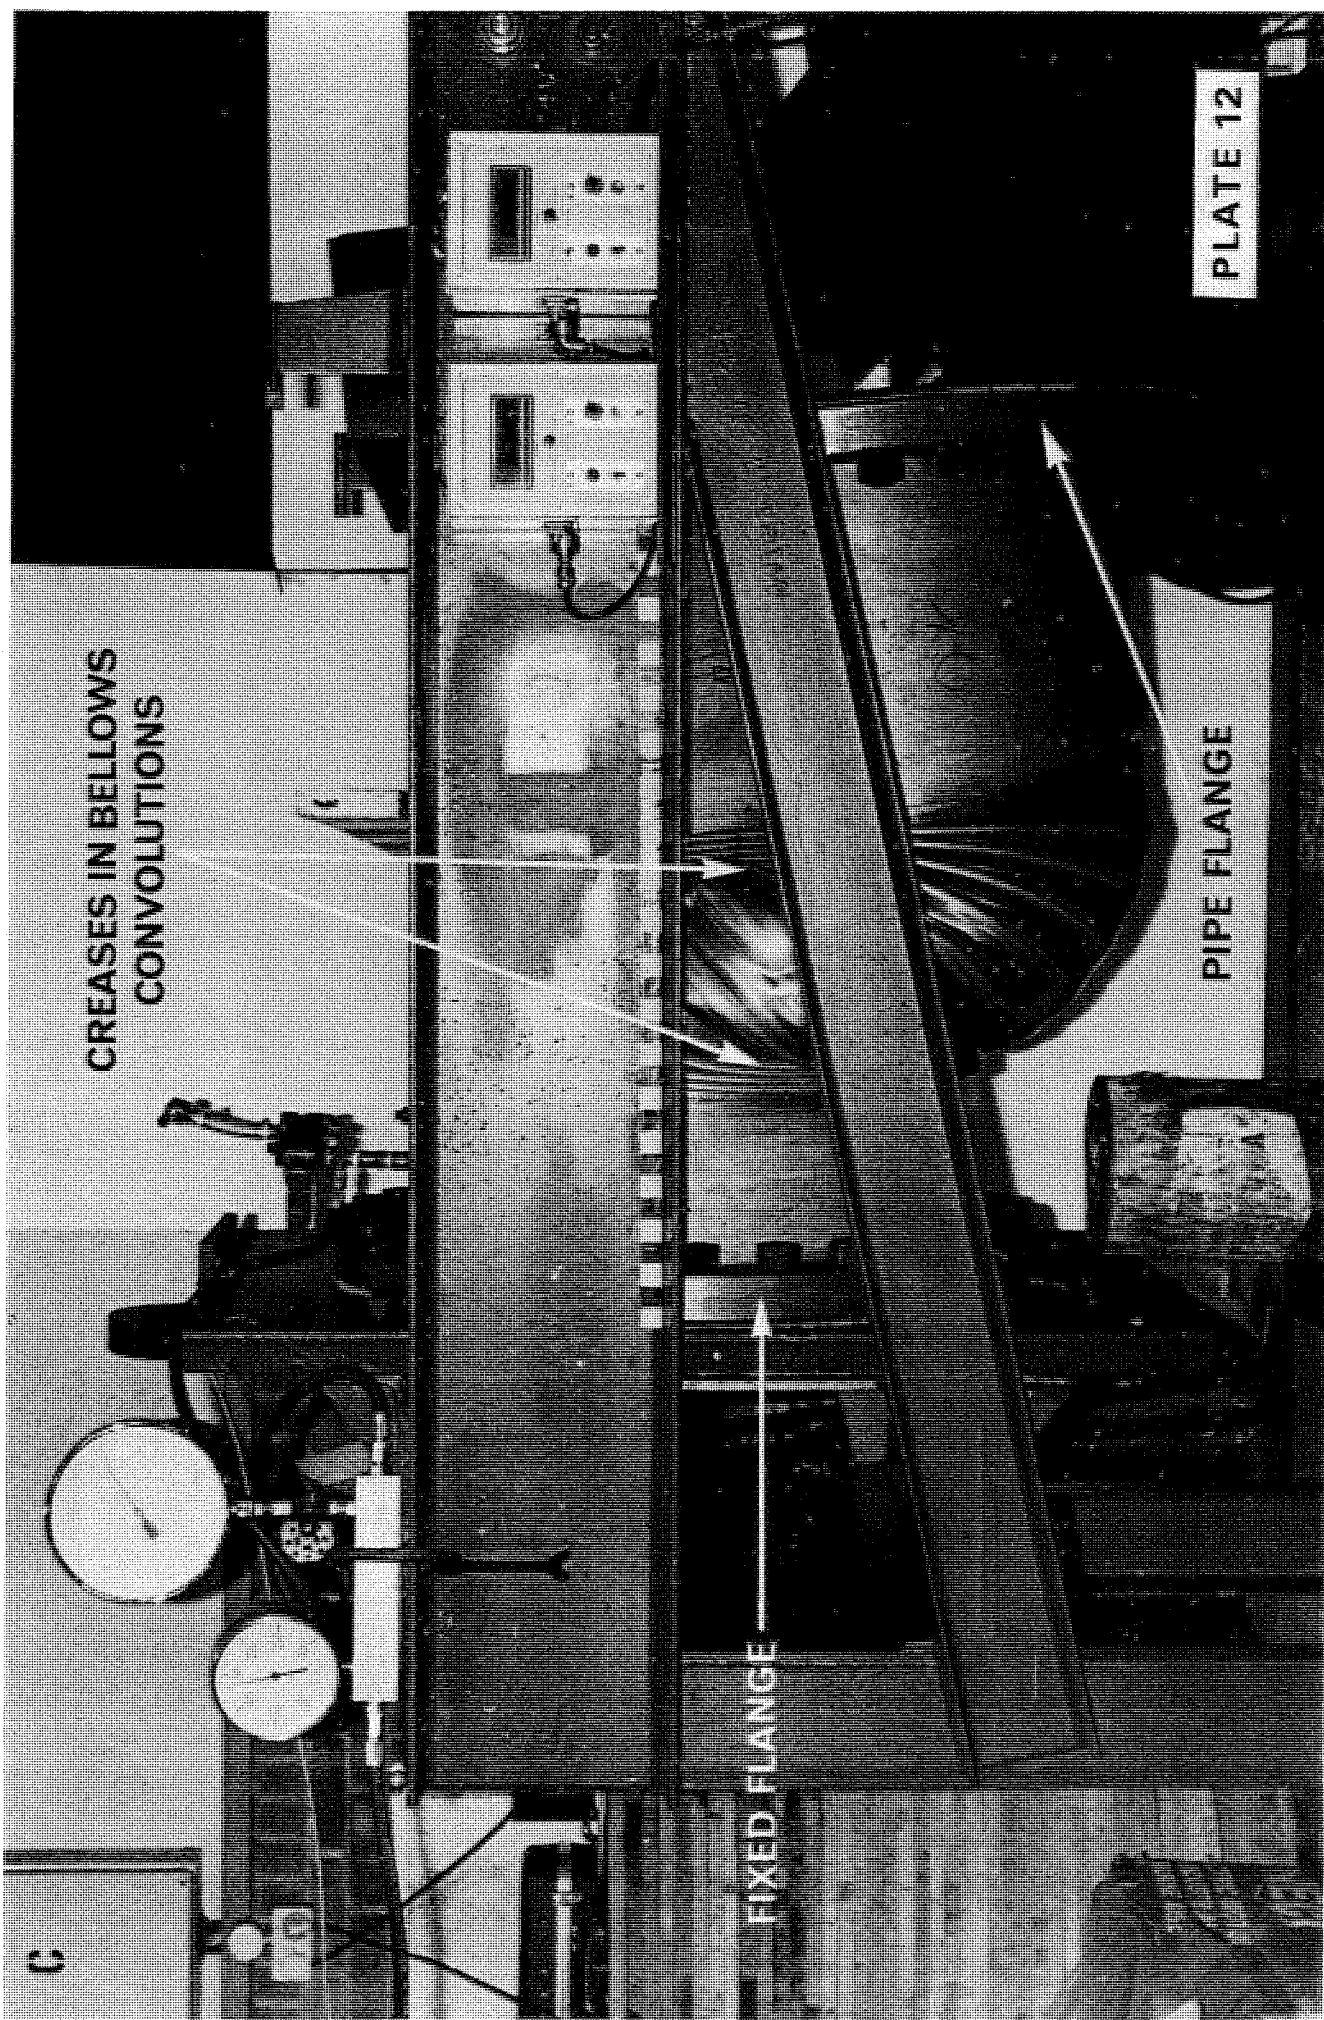
Plate 12 Squirmed bellows in the Nottingham rig. Note the similarity to Plate 11. (See also Fig. 7.)

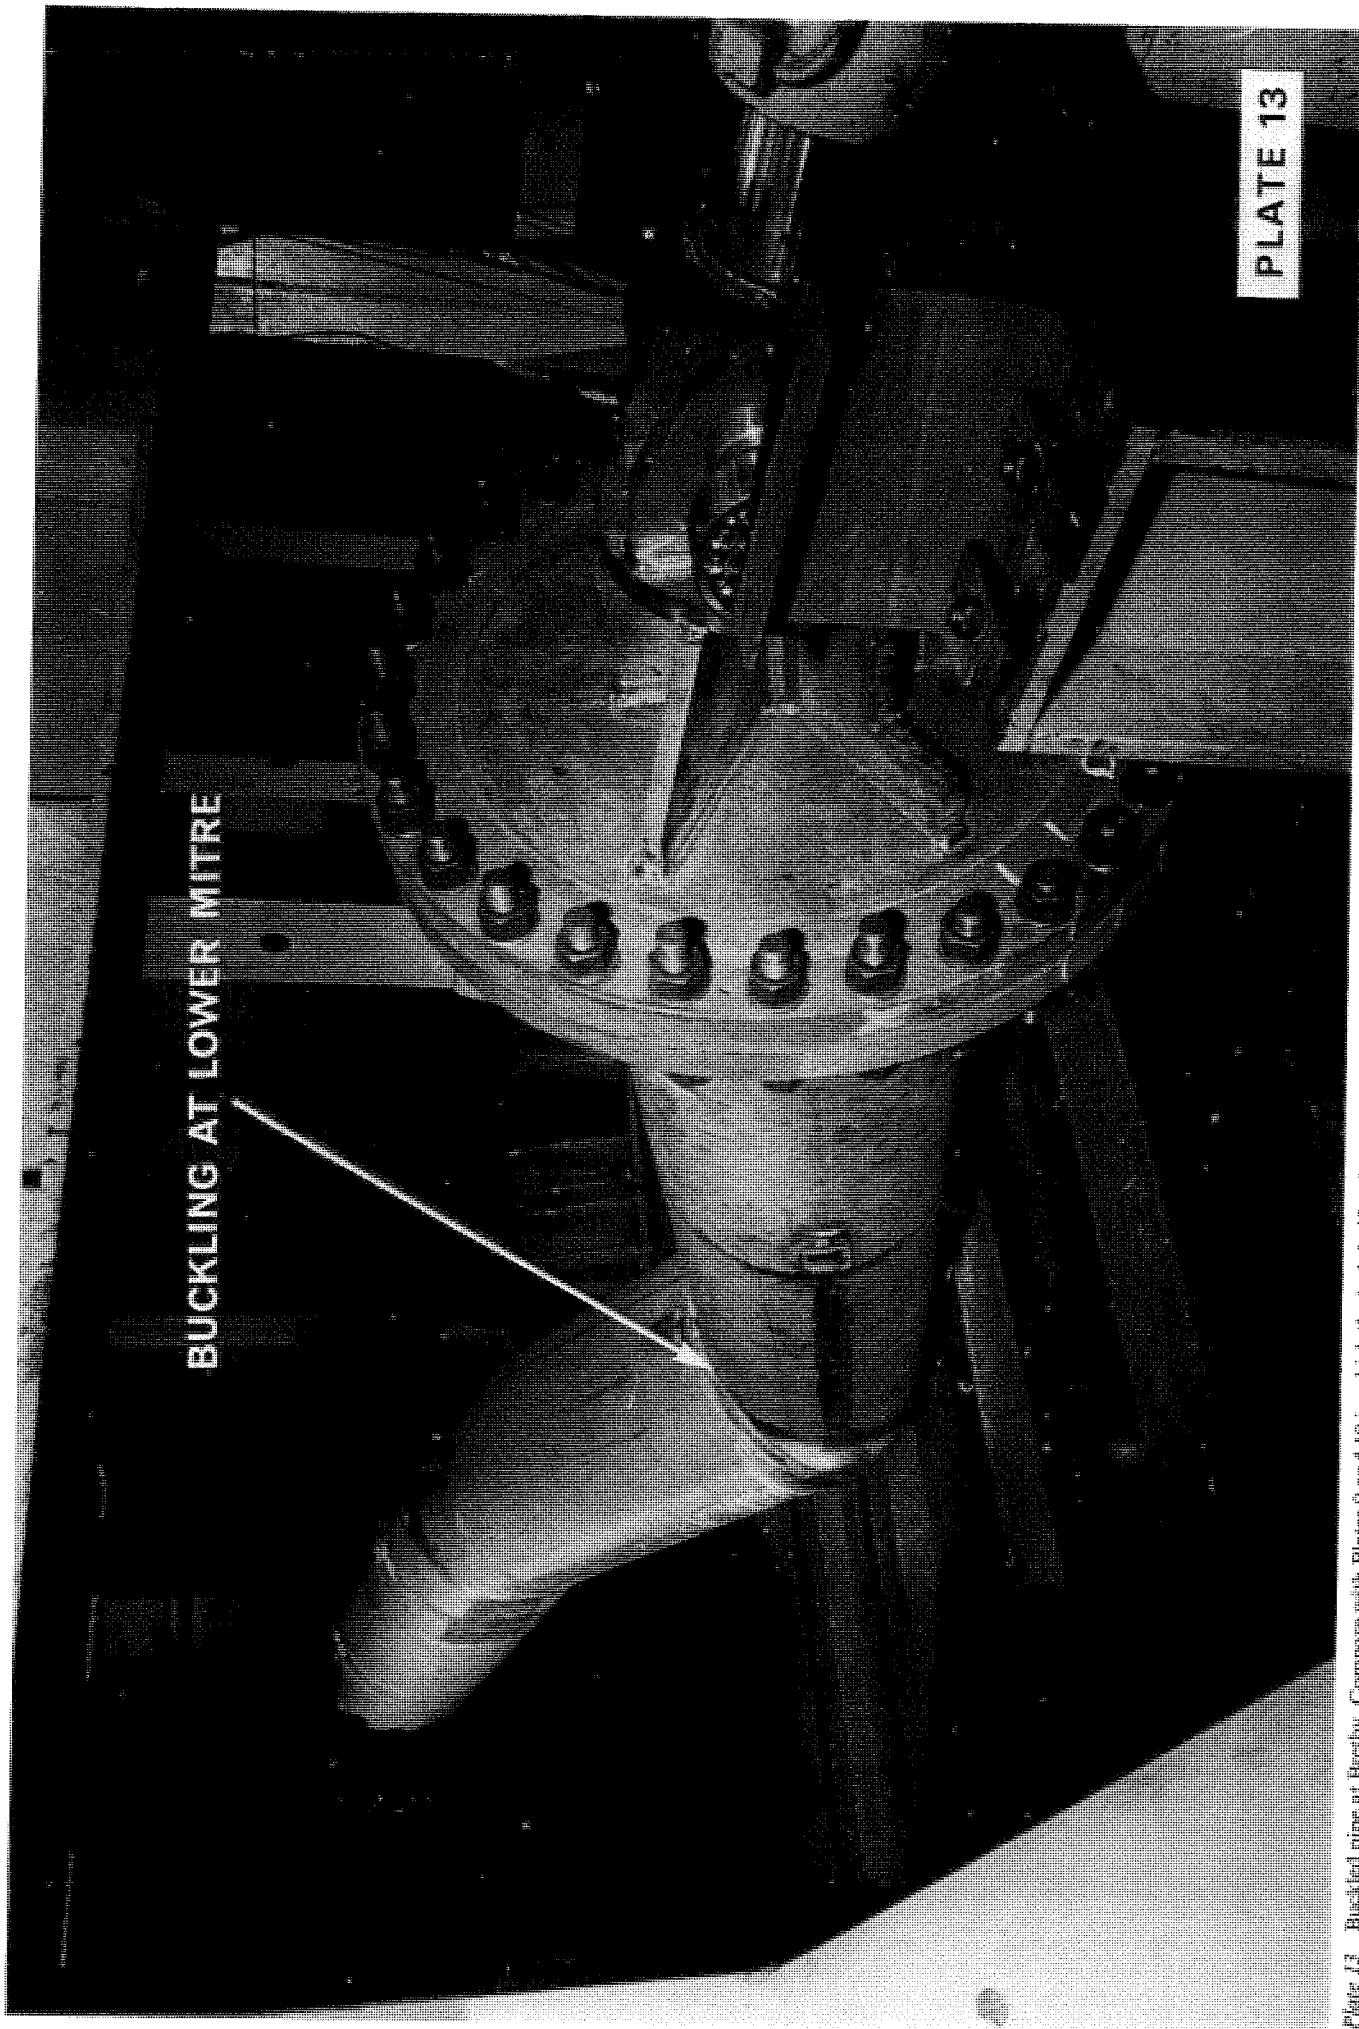
Plate 13 Buckled pipe at Breiby. Compare with Plates 9 and 10 in which the jack-knifing is complete.

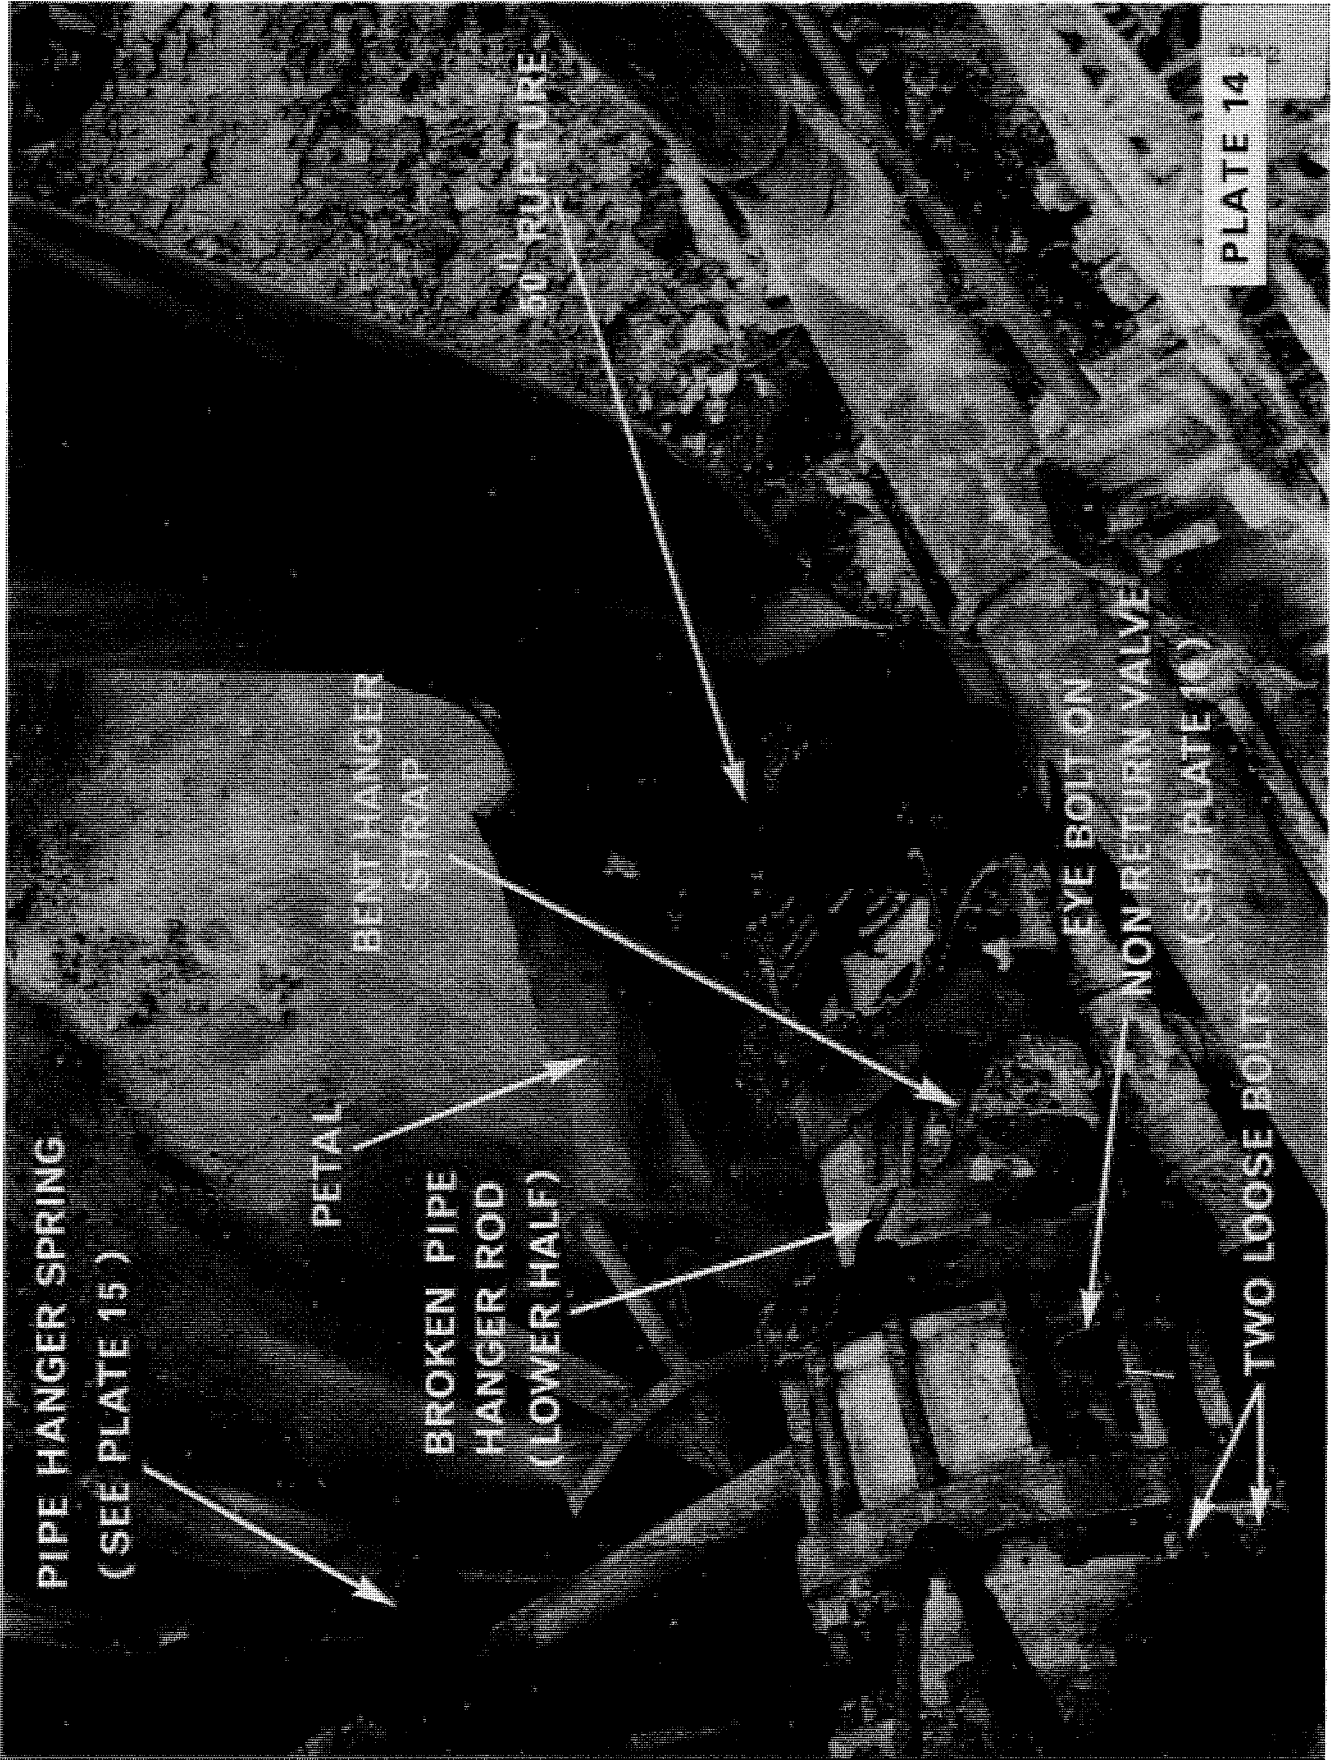
Secondly, a 50 inch split was found in the 8 inch stainless steel piping joining Separators S2538 and S2539 (Plate 14).

Plate 14 The 50 inch rupture on the 8 inch pipe.

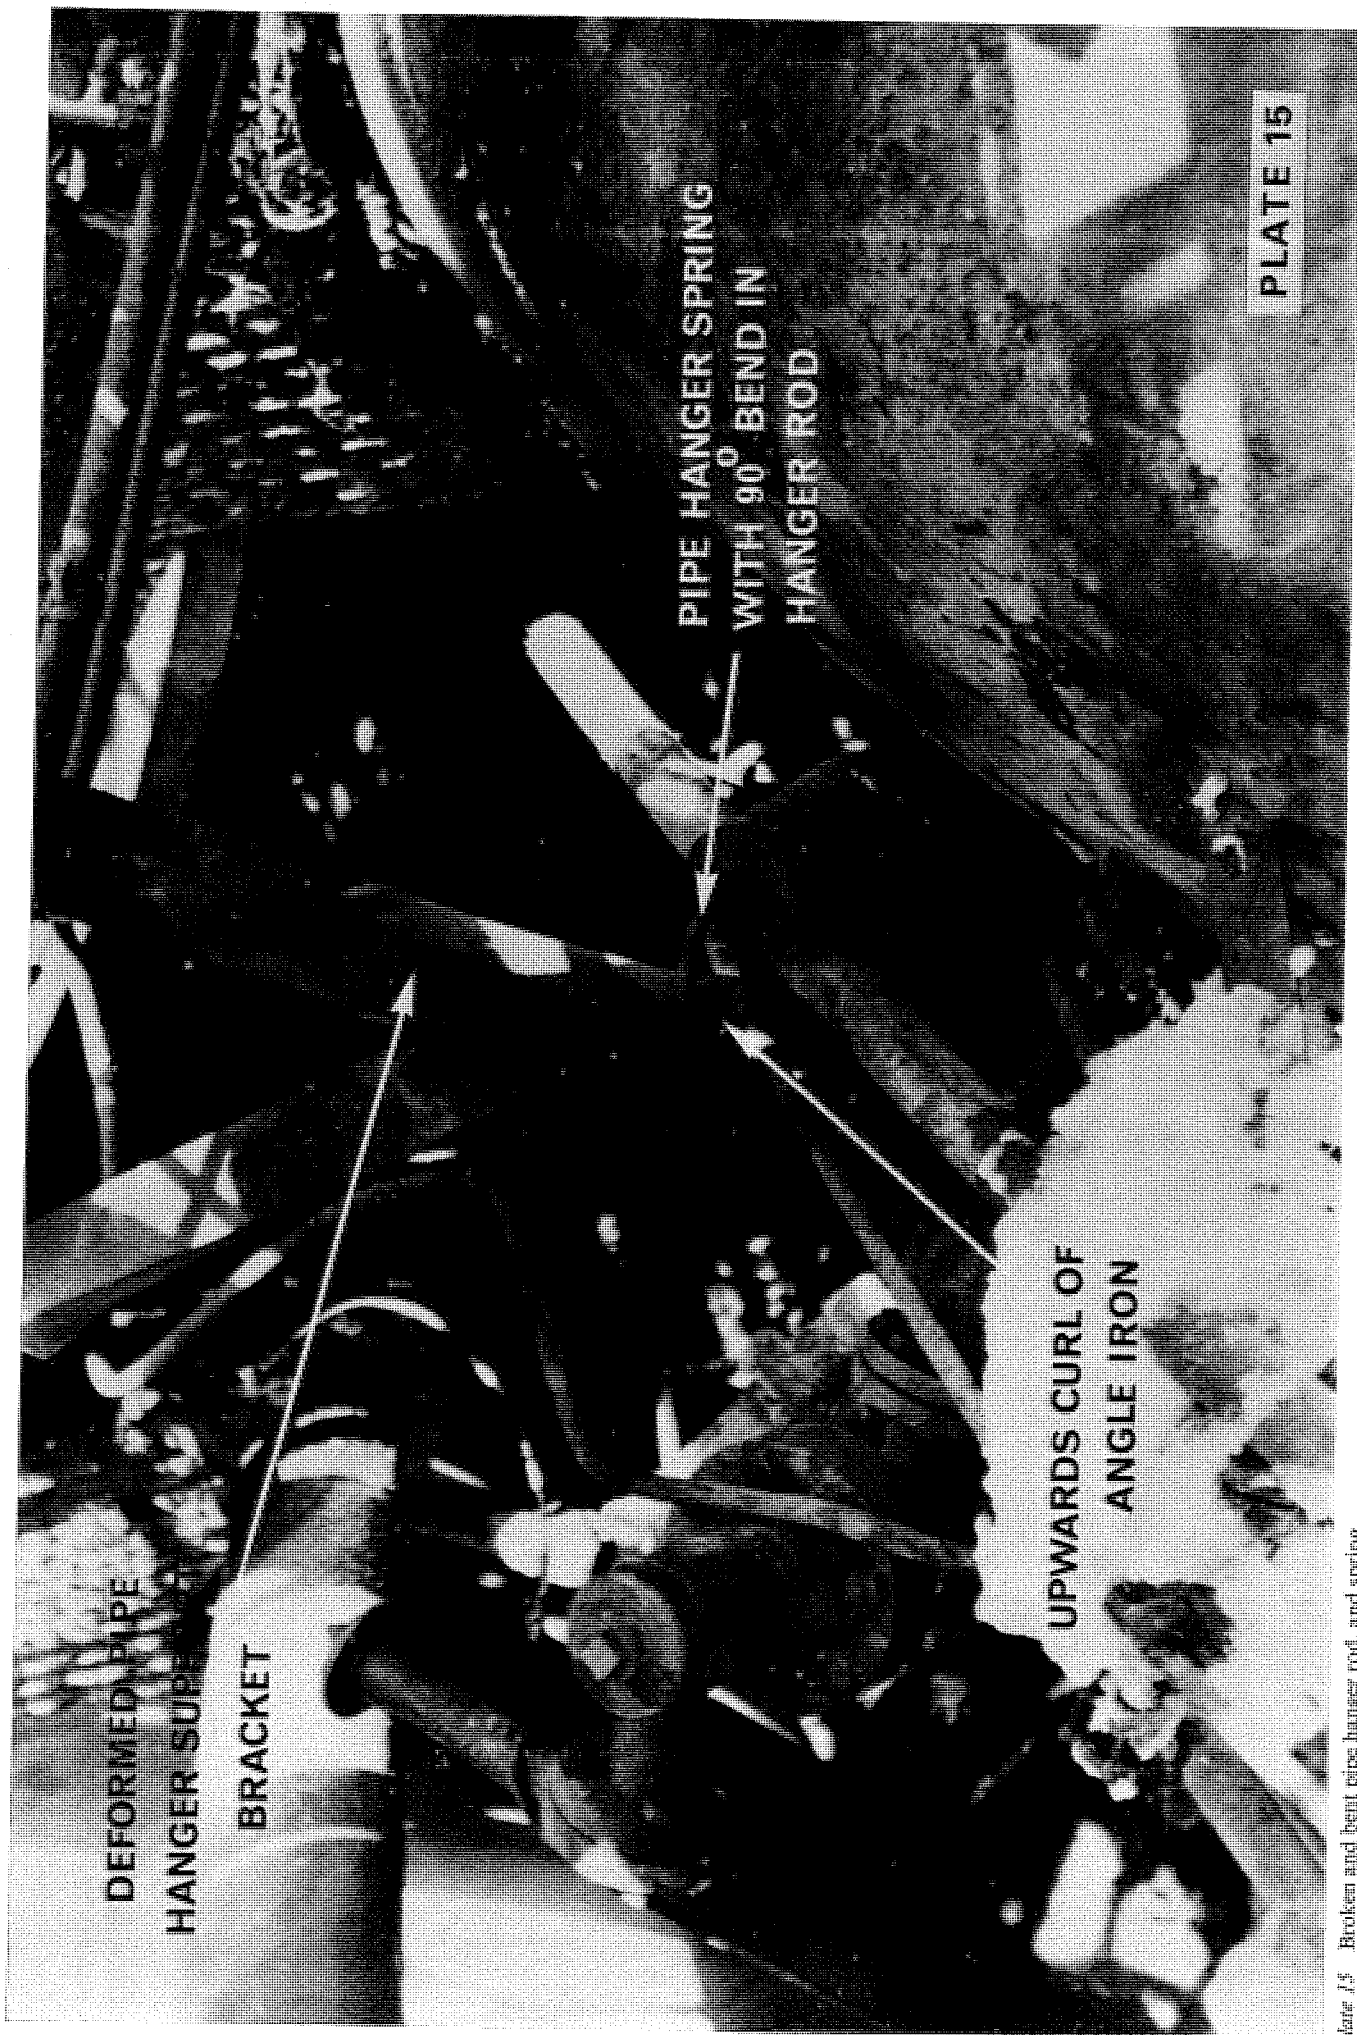
Plate 15 Broken and bent pipe hanger rod, and spring.
