The Flixborough disaster

Report of the Court of Inquiry

**Formal Investigation into Accident on 1st June
1974 at the Nypro Factory at Flixborough**

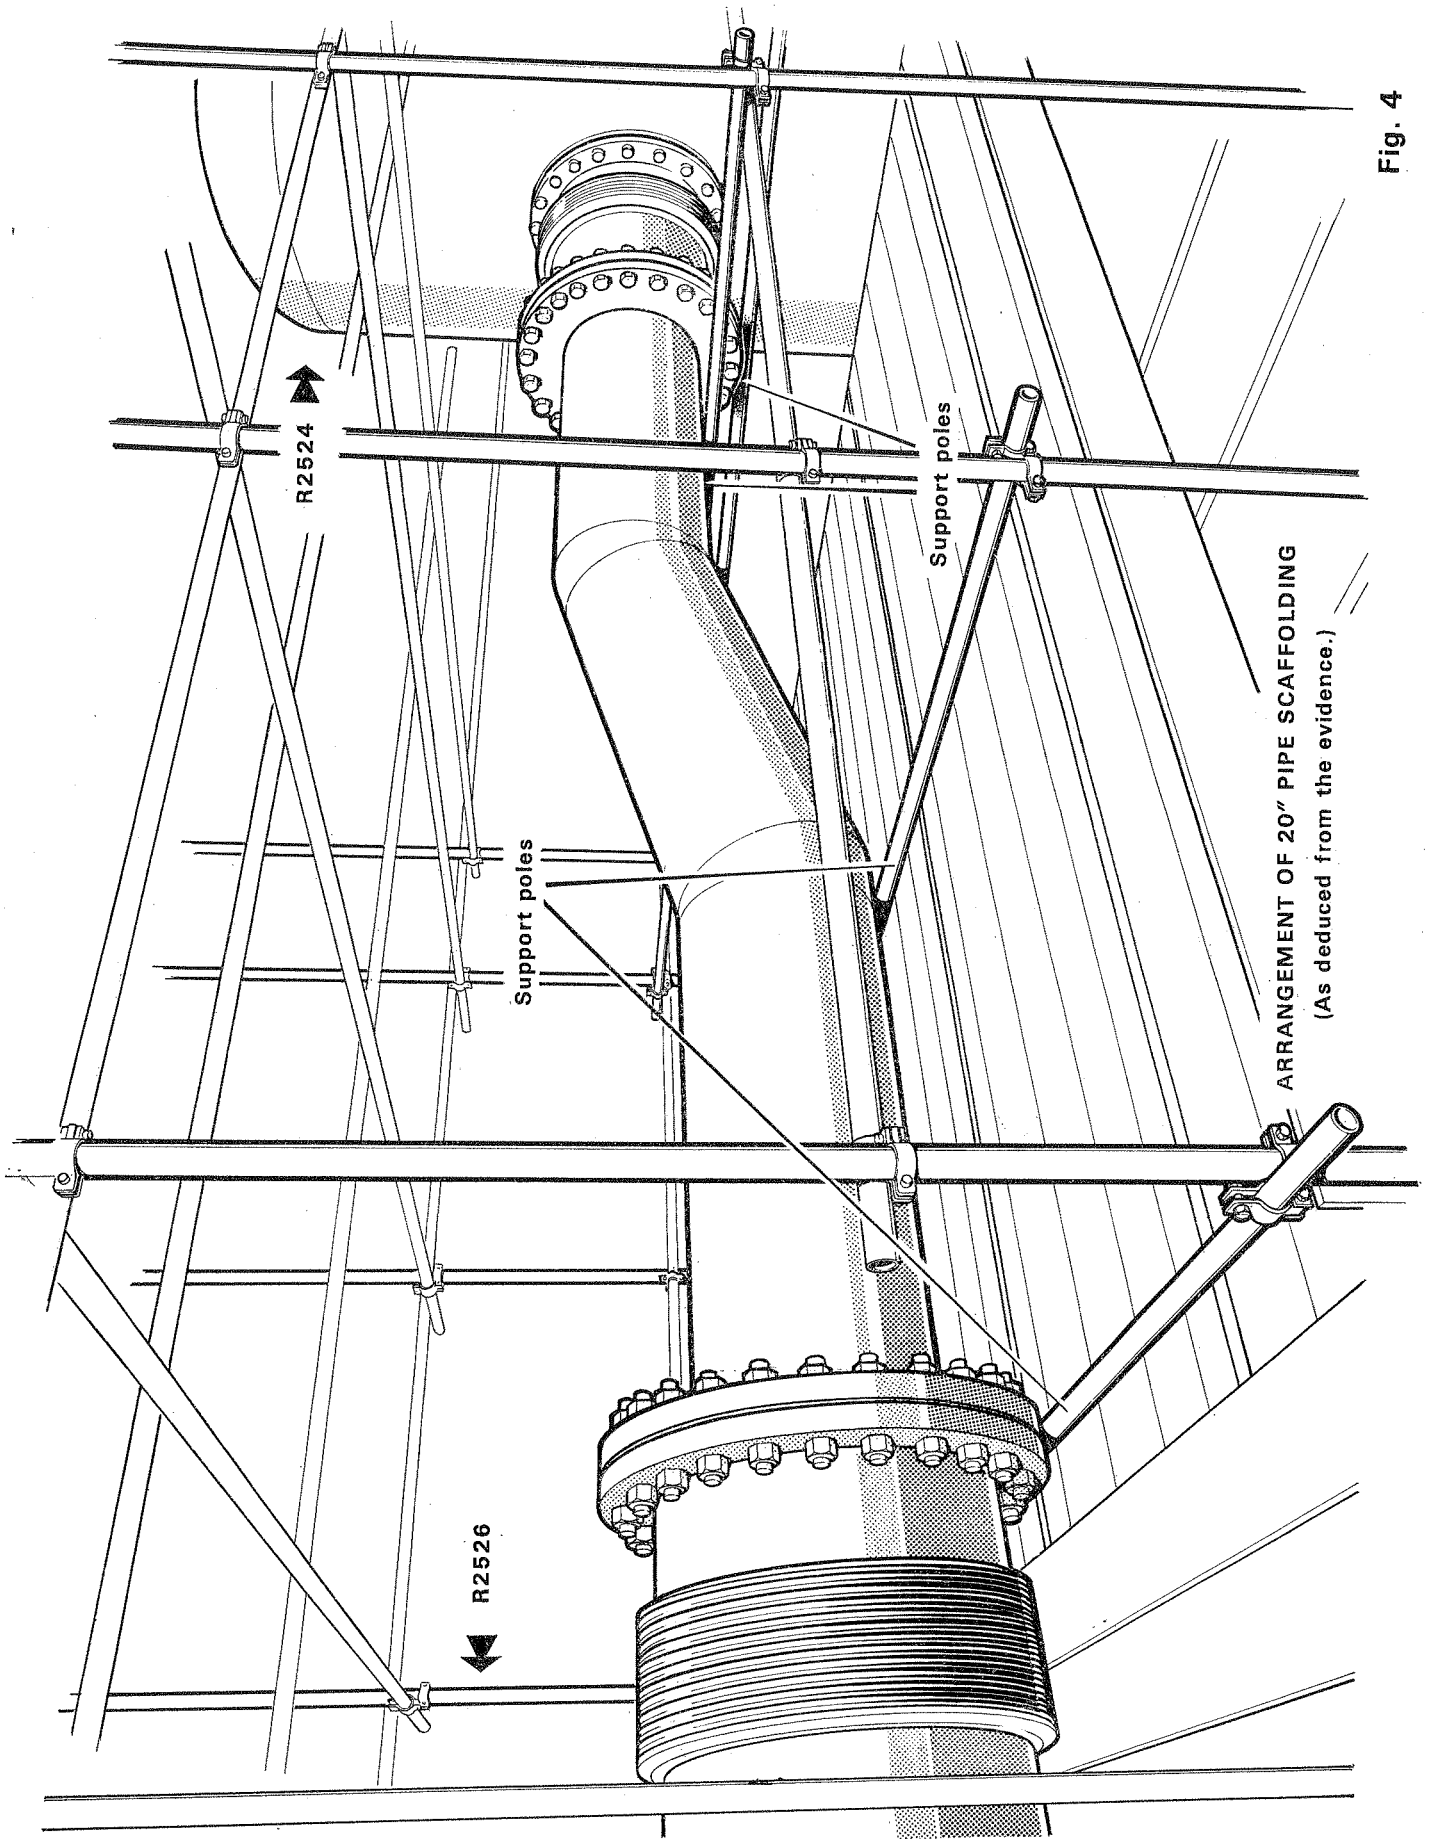
Fig. 4

The approximate position of the four poles supporting the assembly is shown in Fig. 4. No poles or other means were used either to hold the pipe down or to prevent lateral movement. The four poles that were used (as shown on Fig. 4) were intended merely to afford support during assembly to ensure that the bellows were not strained under the weight of the assembly itself. For this purpose they were probably adequate. They were wholly inadequate as supports for the assembly during working conditions. This is not surprising for no thought appears to have been given to the question of desirability of support under such conditions, save by Mr Blackman who at the "design" stage provided Mr Culpin (his assistant) with a sketch for supports bolted to the pipe flanges and firmly attached to the reactor plinth. This support was not, however, provided and Mr Blackman did not take any steps to insist upon its installation.

(iii) As noted in Paragraph 68 and Figure 4, the original pipe had partial support from scaffold poles.

ARRANGEMENT OF 20" PIPE SCAFFOLDING
(As deduced from the evidence.)

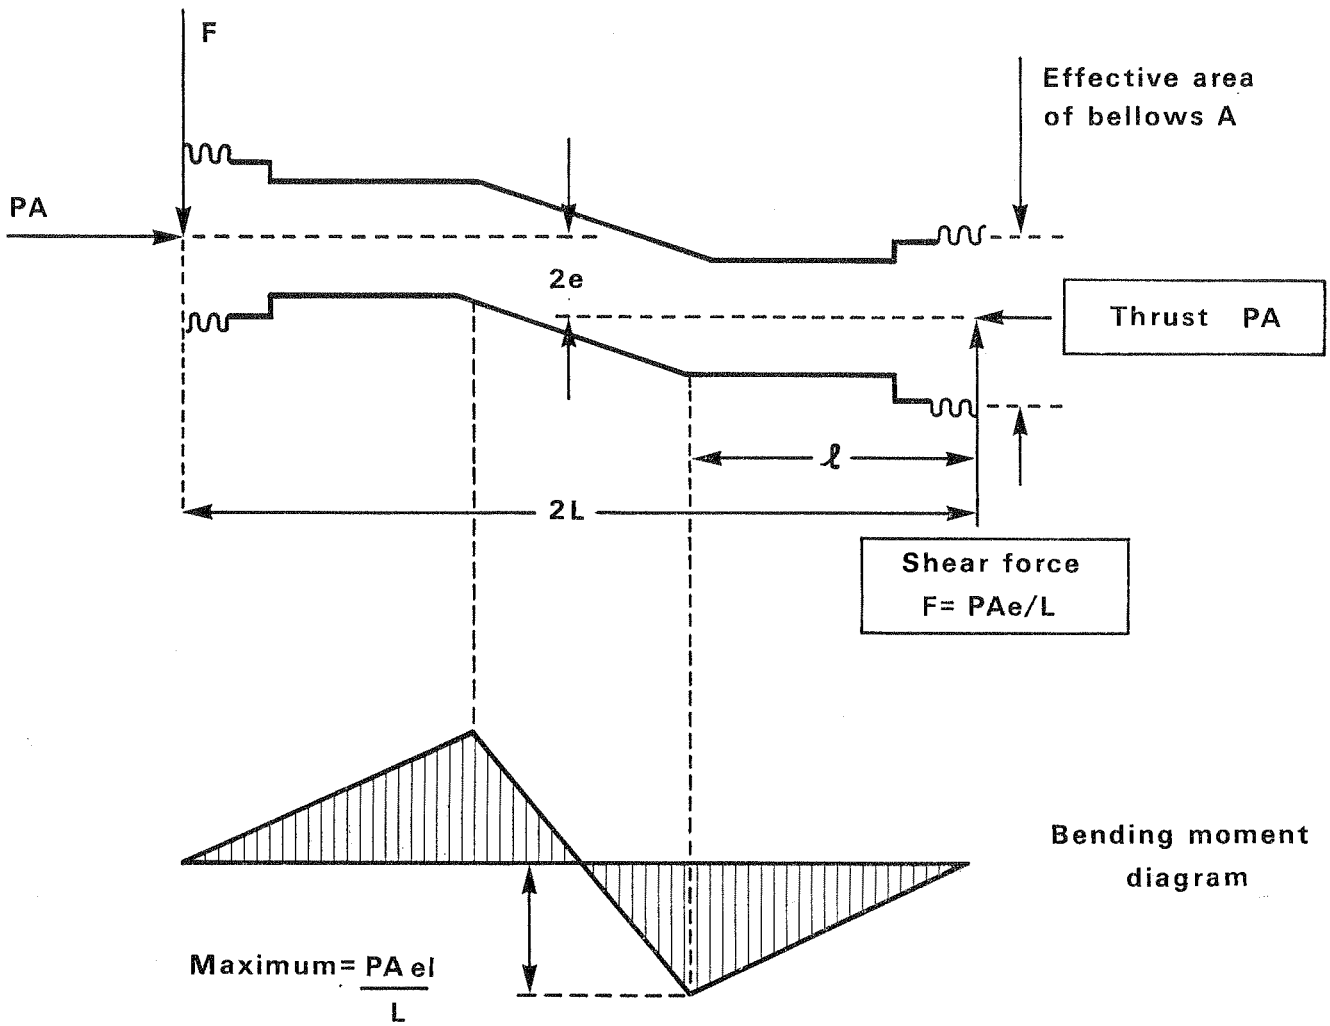
Fig. 6

SKETCH OF PIPE AND BELLOWS ASSEMBLY SHOWING SHEAR FORCES ON BELLOWS AND BENDING MOMENTS IN PIPE (DUE TO INTERNAL PRESSURE ONLY)

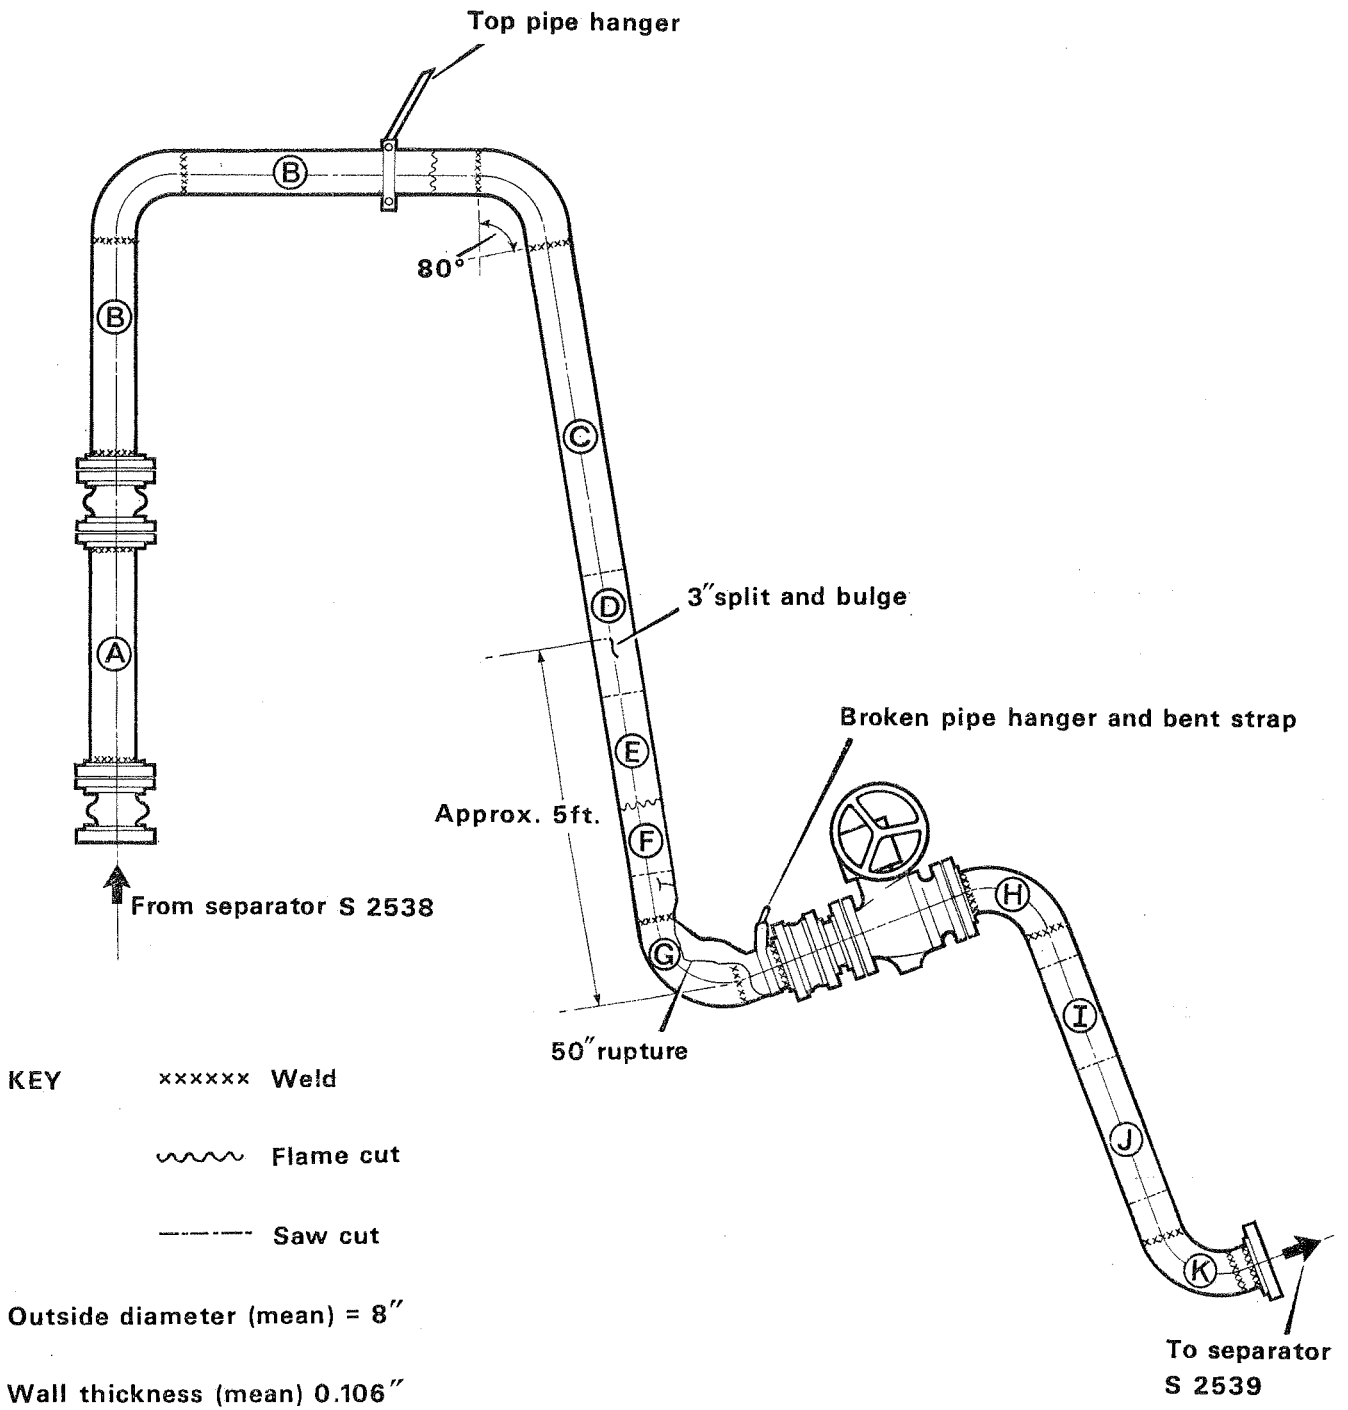
Fig. 10

THE DAMAGED 8" PIPE
