**AIRCRAFT ACCIDENT REPORT**

**HELIOS AIRWAYS FLIGHT HCY522  
BOEING 737-31S  
AT GRAMMATIKO, HELLAS  
ON 14 AUGUST 2005**

**ACCIDENT INVESTIGATION REPORT  
11 / 2006**

Accident of the a/c 5B-DBY of Helios Airways,  
Flight HCY522 on August 14, 2005,  
in the area of Grammatiko, Attikis,  
33 km Northwest Of Athens International Airport

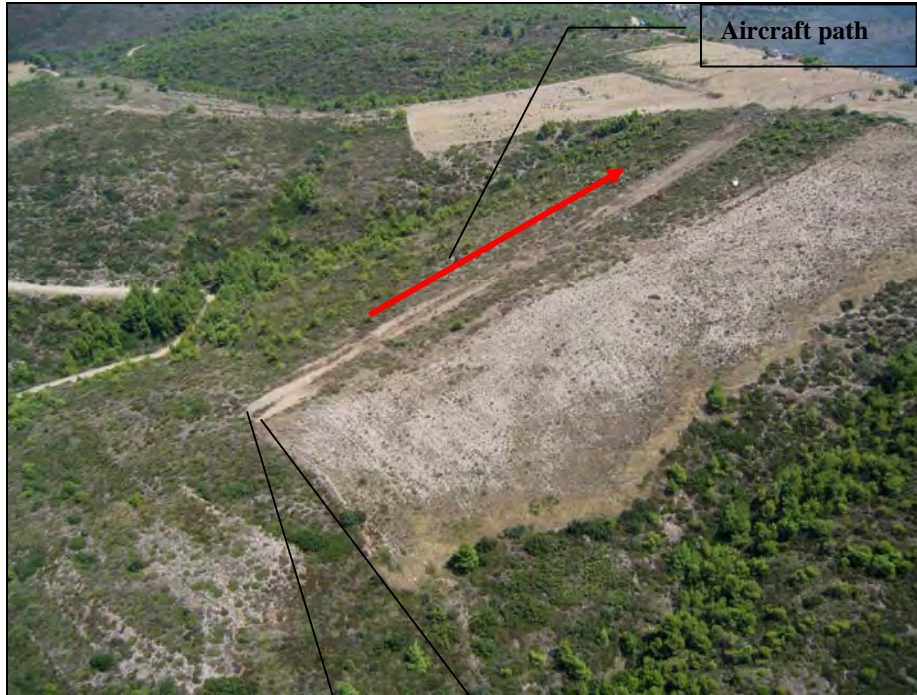
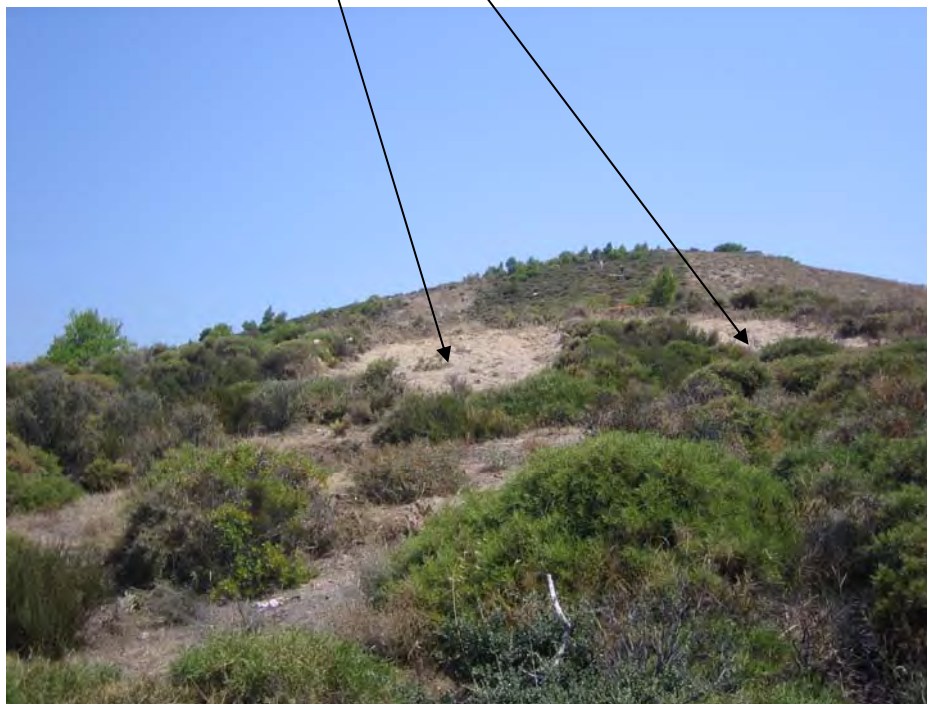
Two adjacent dirt paths (gouges) were found at the initial impact area, which matched the spacing of the fuselage to the right engine. The dirt paths passed through low vegetation on the first uphill slope (See photos on the next page). The wider path was found to be consistent with the 3.7 m width of the fuselage and the adjacent path to the right was consistent with the 2.4 m width of the engine. A third dirt path was found to the left, 10 m down-track from the initial contact of the fuselage and right engine. The location of this dirt path was consistent with the spacing of the left engine from the initial impact of the fuselage and right engine. A 35 cm wide slice through the vegetation began 9 m to the right of the fuselage centerline and 5 m down-track from the initial contact of the fuselage and right engine.

**Photos – Initial impact area and first two contact paths on first uphill slope. The path with the width of the fuselage begins in the center of the photo and the path with the spacing and width of the right engine begins near the right side. The slope of the hill is visible as darkening of the path. For scale, the two people immediately beneath the peak of the hill are barely visible.**

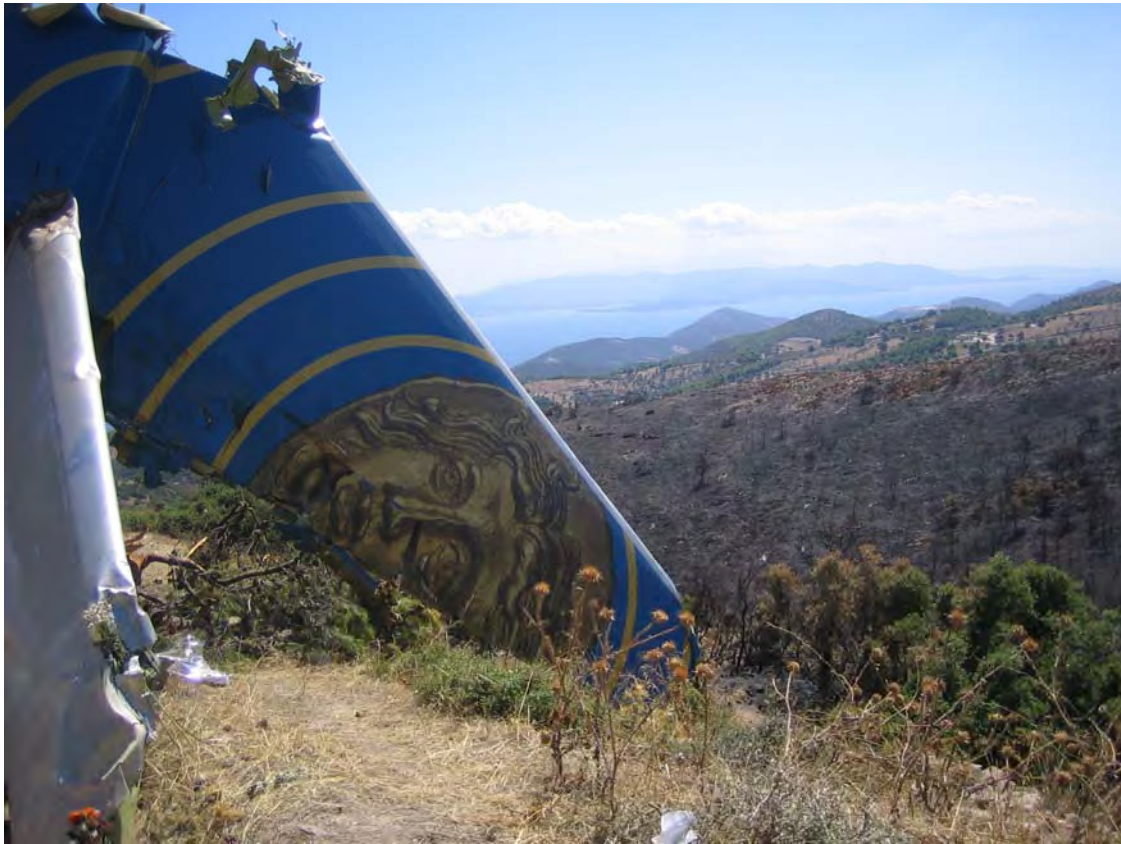
**Photo – The tail assembly near the crest of the first hill, with the distant crest of the second hill in the background.**

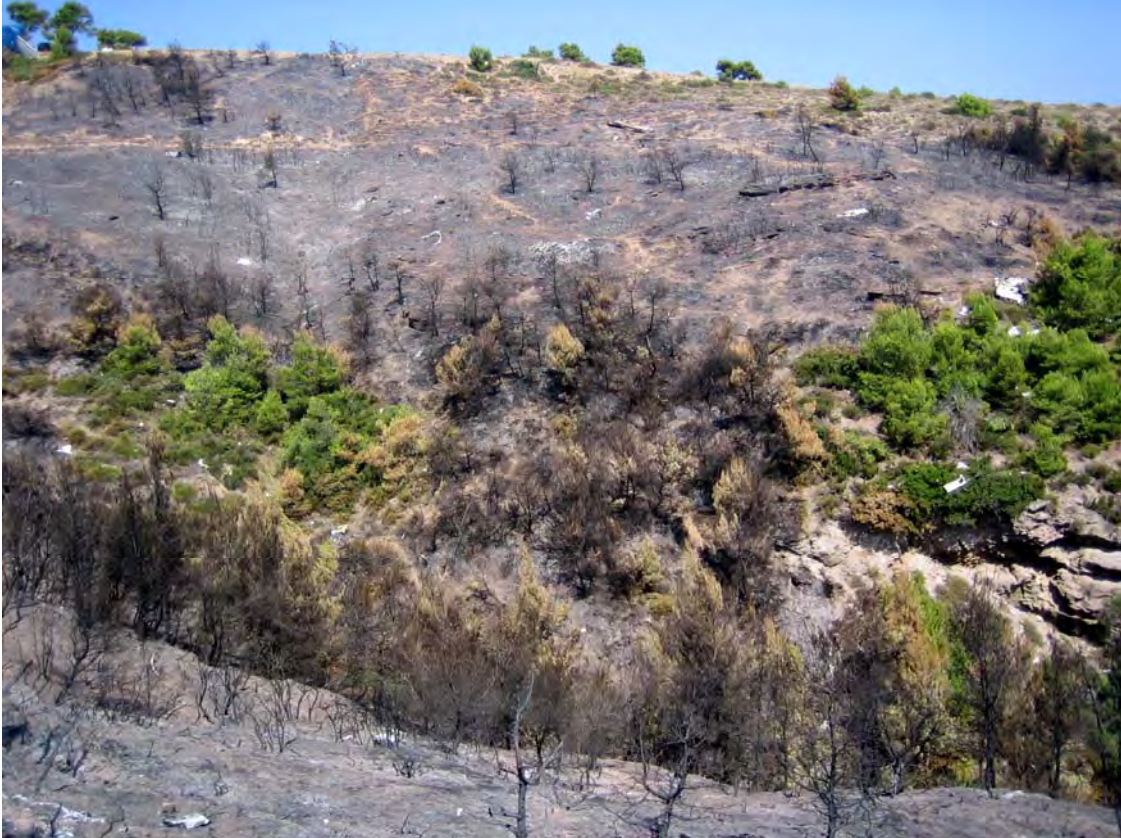
**Photo – Viewed backward from the second hill, this photo looks at the downward slope of the first hill into a ravine. The tail assembly is at the extreme upper left corner, beneath the two trees. The skin of the right aft fuselage and top of fuselage is the white material at the right edge of the photo, above the green vegetation. The upper edge of the first ravine is visible along the bottom of the photo, which then drops out of sight.**

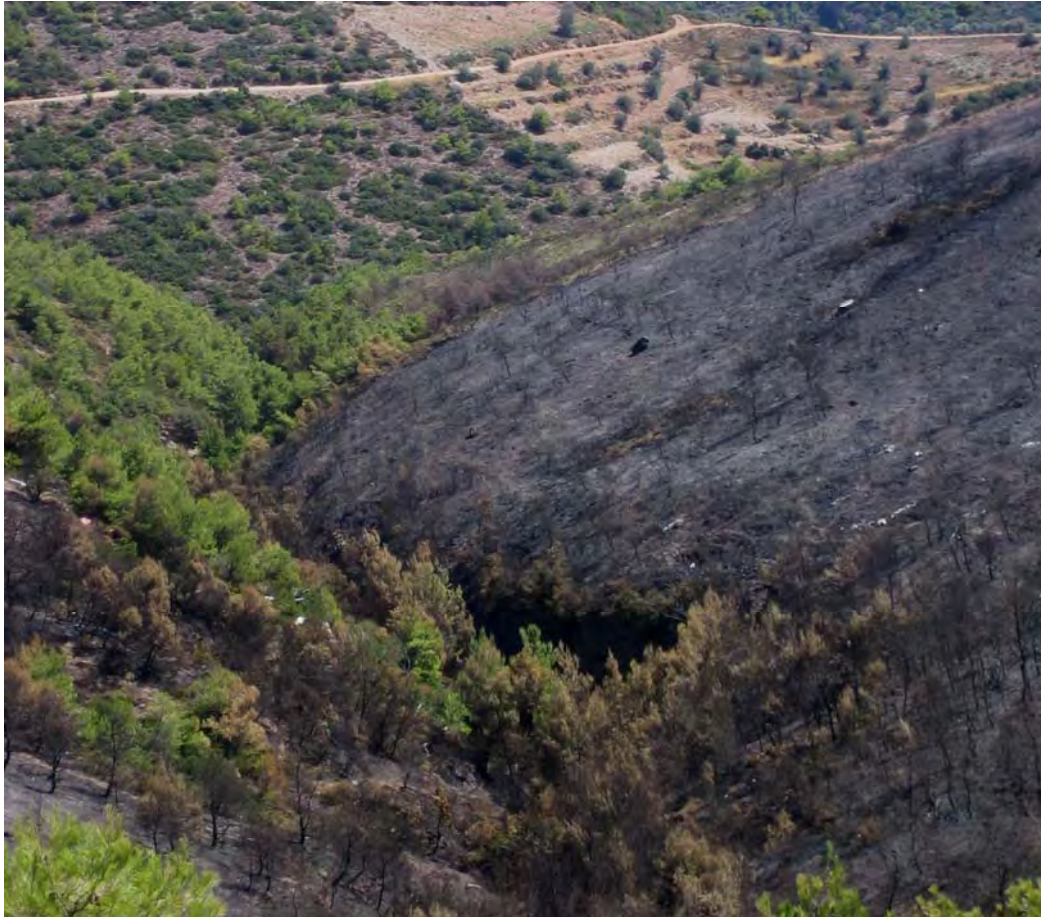
**Photo – The downhill slope from the first peak is to the left and the upward slope to the peak of the second hill is to the right. The dark debris in the center of the upward slope to the right is half of the left engine.**

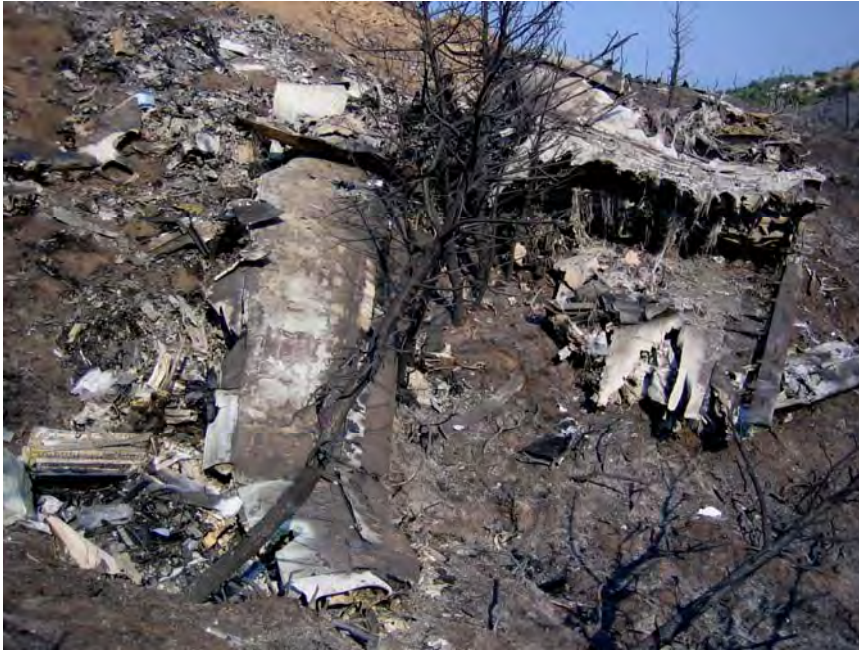
The nearly complete wings assembly was found about halfway down the second slope. The main landing gear well was burned out and was found about 12 m uphill from the wings. The wings were found folded so that the tips were downhill (See photo below).

**Photo – The right wing tip is at the lower left and the left wing is at the right edge of the photo. The center section and main gear well is at top right.**

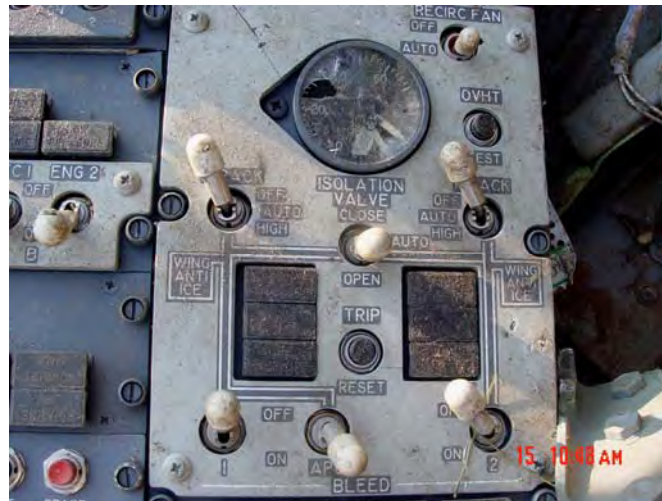
**Photo – Air Conditioning Panel**

The P5-10 air conditioning panel remained in the P5 overhead panel (See photo below). The panel was photographed and the positions of each toggle switch and the duct pressure indicator were documented.

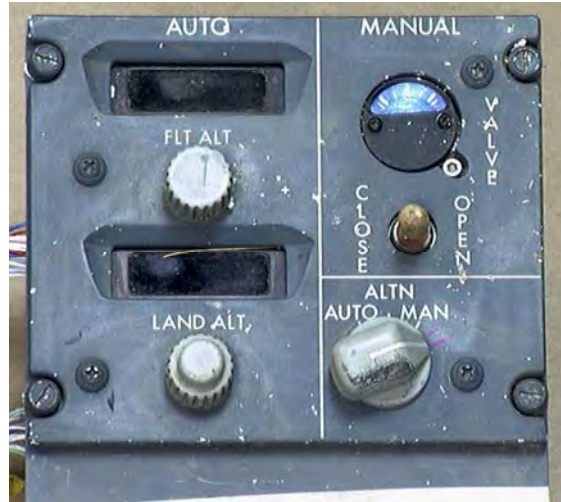
**Photo – Pressurization Panel**

The P5-5 cabin pressurization panel was found intact and remained in the P-5 overhead panel. The position indicator of the cabin pressure mode selector was found rotated past the MAN (manual) position (on the faceplate) by approximately 7.0 mm. It was later determined by the Boeing EQA that the damage was consistent with physical impact. The selector had an abrasion, in line with the selector line, on its right side at the lower corner. The panel face plate in the vicinity of the AUTO nomenclature had a 180 degree circular impression of the selector base. The center mark on the selector was about 10 degrees from the start of the circular impression (See photo below).

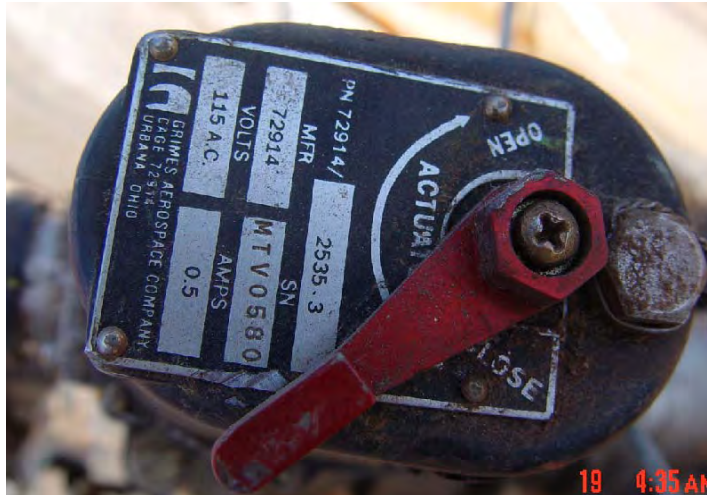
**Photo - Forward Outflow Valve**

The Forward Outflow Valve (photo below), manufactured by Grimes Aerospace Co., was found intact and connected to its ducting. The manufacturer Commercial and Government Entity (CAGE) code number on the actuator was 72914, which indicated that the actuator was made by Honeywell (the parent company of Grimes Aerospace Co.). The part number and serial number of the actuator were 2535-3 and MTV0580, respectively. The actuator was a subassembly of the Forward Outflow Valve, P/N 32-2684-007. The valve position indicator lever remained in the closed position, and an electrical connector remained connected to the valve assembly. A tag on the valve stated *“installation eligibility Boeing 747-200, 747-300, 747-400.”* According to Boeing, this valve is the *“approved 737 forward outflow valve as verified by part number 32-2684-007 ... the part is also approved for use on the 747.”* The butterfly valve contained within the assembly was in the closed position.

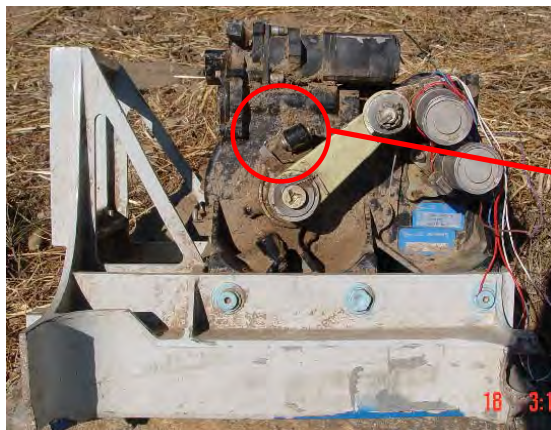
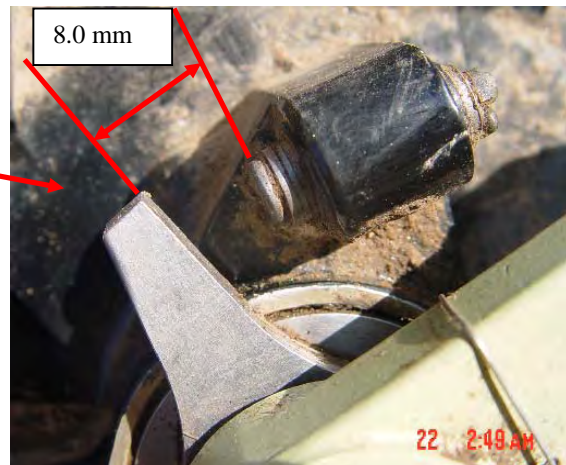
**Photo - Aft Outflow Valve at accident site**

The actuator/motor assembly and both the forward and aft door gates of the aft outflow valve (AOV) were found at the accident site (see diagram and photos below and next page). The actuator/motor assembly was separated from each of the door gates. The condition of the actuator/motor assembly was documented and photographed at the accident site. The control arm and position indicator remained attached to the motor assembly. Using hand pressure, a small force was applied to the control arm; it was physically locked in place and not able to rotate freely. At the storage facility, a measurement was taken between the closed position stop and the control arm position lever; the distance between the two was 8.0 mm (see photo in the next page).

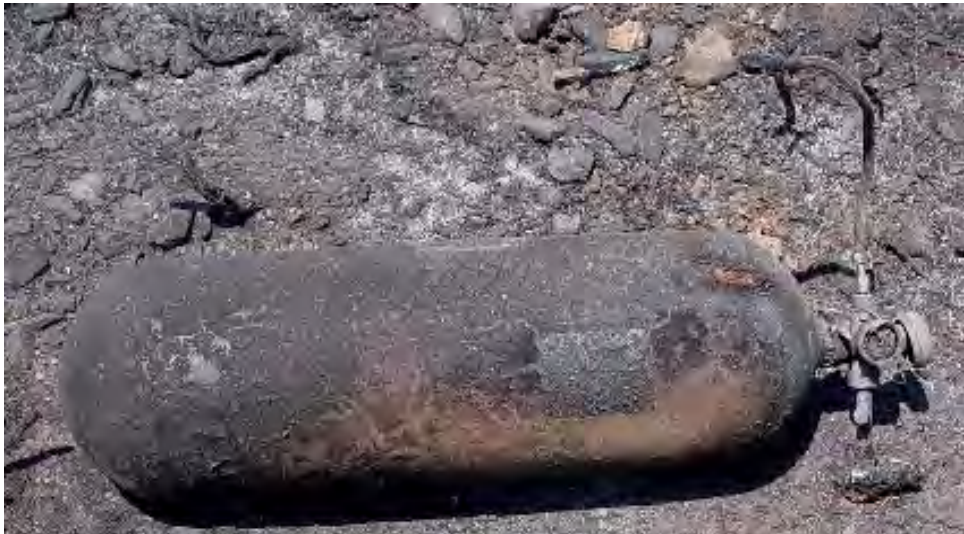
**Photo - Flight deck oxygen cylinder**

The flight deck oxygen cylinder was found heat damaged and the regulator was missing. (See photo - Flight deck oxygen cylinder). The shutoff valve assembly was observed to be loose on the cylinder and it could easily be rotated in the clockwise and counter-clockwise direction. At the storage facility, the cylinder was visually examined and the regulator valve was physically rotated. Using hand pressure, a force was applied to the regulator valve in the counter-clockwise (valve open) direction; the valve did not rotate. Using hand pressure, a force was applied to the regulator valve in the clockwise (valve closed) direction; the valve rotated six revolutions. The cylinder was empty. The last hydrostatic check had been carried out in September 2003 (09/03 dye stamp on cylinder neck).

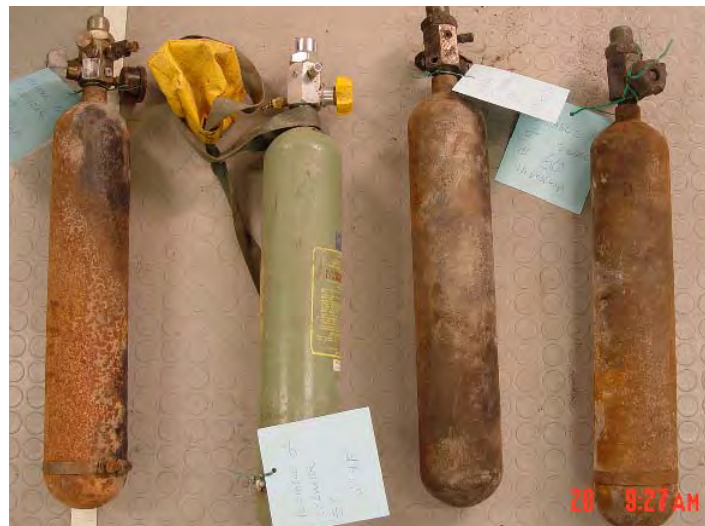
**Photo – Portable Oxygen Bottles**

- Bottle number 4: The bottle had been exposed to heat. The paint was missing and the exterior of the bottle appeared to be slightly rusted. The shut-off valve was rotated 1 ½ revolutions clockwise to the fully closed position.

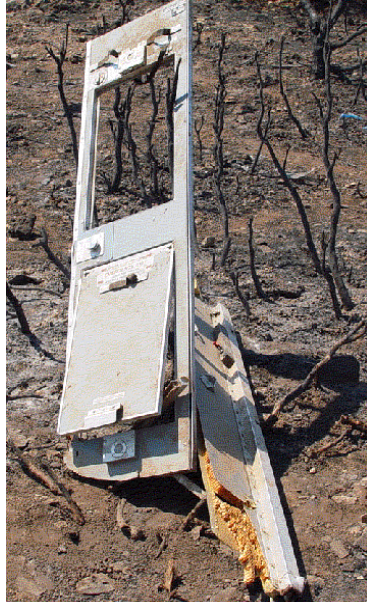
**Photo – Flight deck door**

on either side of flight deck door faces or lower blow out panel. The door upper blow-out panel was missing. The flight deck access system guarded switch on the door side post fragment was observed to be positioned to “NORM”. The flight deck door deadbolt was found in the “UNLOCKED” position (vertical).

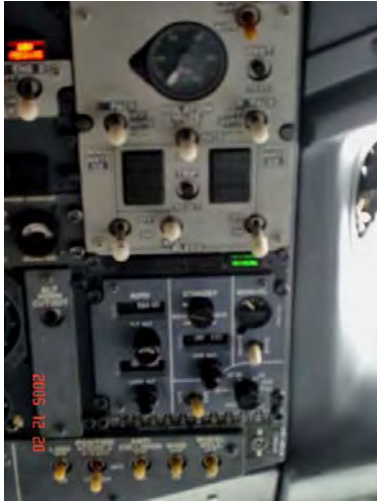
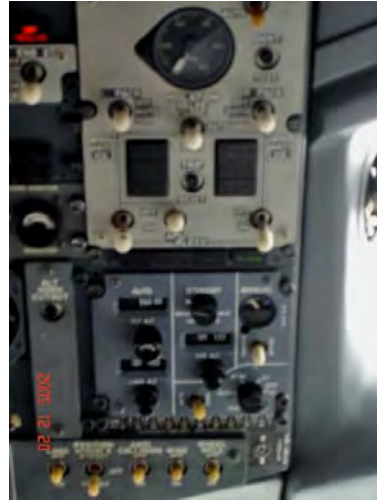
on DIM and looking up to the overhead panel from the First Officer's seat, the green annunciation MANUAL was not particularly obvious.
