**AIRCRAFT ACCIDENT REPORT**

**HELIOS AIRWAYS FLIGHT HCY522  
BOEING 737-31S  
AT GRAMMATIKO, HELLAS  
ON 14 AUGUST 2005**

**ACCIDENT INVESTIGATION REPORT  
11 / 2006**

Accident of the a/c 5B-DBY of Helios Airways,  
Flight HCY522 on August 14, 2005,  
in the area of Grammatiko, Attikis,  
33 km Northwest Of Athens International Airport

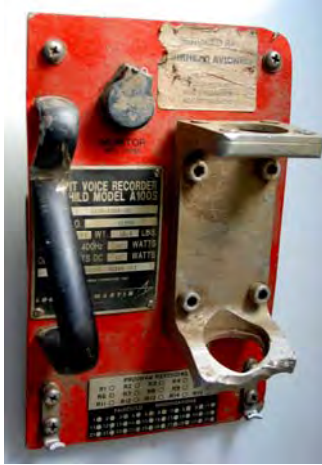
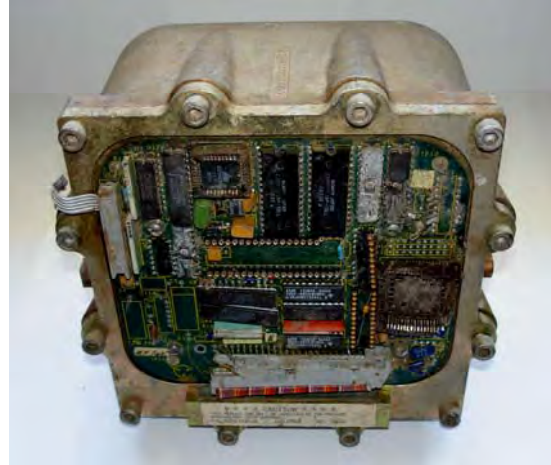
**Photo – CVR**

The CVR was taken to be transcribed at BEA (Bureau d’ Enquêtes et d’ Analyses) in France. The Flash Card Survivable Store Unit (FCSSU) was opened and the memory board was extracted. The memory board was connected to the acquisition part of the Solid State CVR by a cable from the FCSSU (memory-protected module). The cable was found in good condition; a new connector was plugged into the cable, which was then connected to BEA’S A100S unit, which was used as a reader. After the data extraction was completed, the last 30 minutes of the recording was obtained.

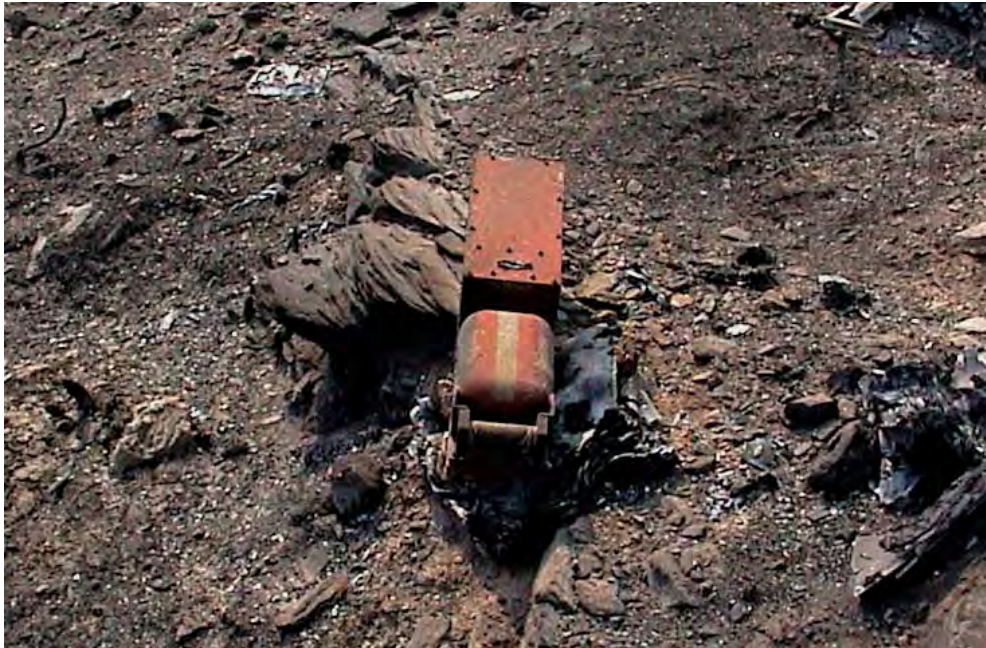
**Photo - FDR**

The FDR was found near the right aft service door and was recovered from the accident site on 14 August 2005, the day of the accident (Photo – FDR). It was taken to the readout facilities of BEA and the read out began on 17 August 2005. The recorder was in good condition, with no evidence of impact damage. However, the outside casing, including the outside of the acquisition unit, was blackened by fire expose and the paint was melted. Since it bore signs of fire exposure, the protected unit was removed from the FDR and connected to a new acquisition unit. It was then connected to the readout equipment, in order to download the raw data file. The data file was synchronized using BEA software.

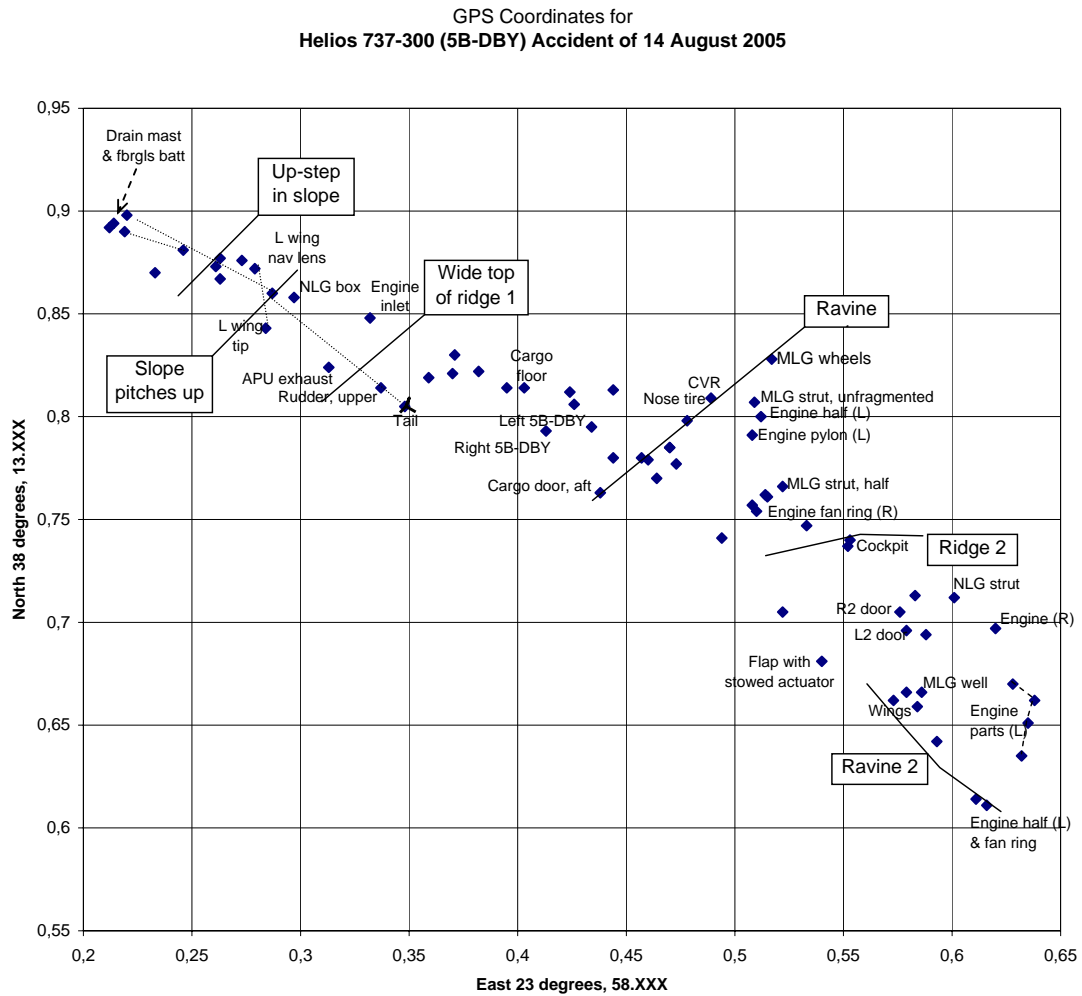
**Diagram – Wreckage Distribution Map**

The wreckage was distributed generally from west to east, over two rocky hills for a straight-line distance of about 800 m (Diagram - Wreckage Distribution Map and in Appendices the Wreckage Distribution Position Data). The first component found was a drain mast where the fuselage first impacted the ground. Tufts of fiberglass thermal-acoustic insulation batting were in the immediate area.

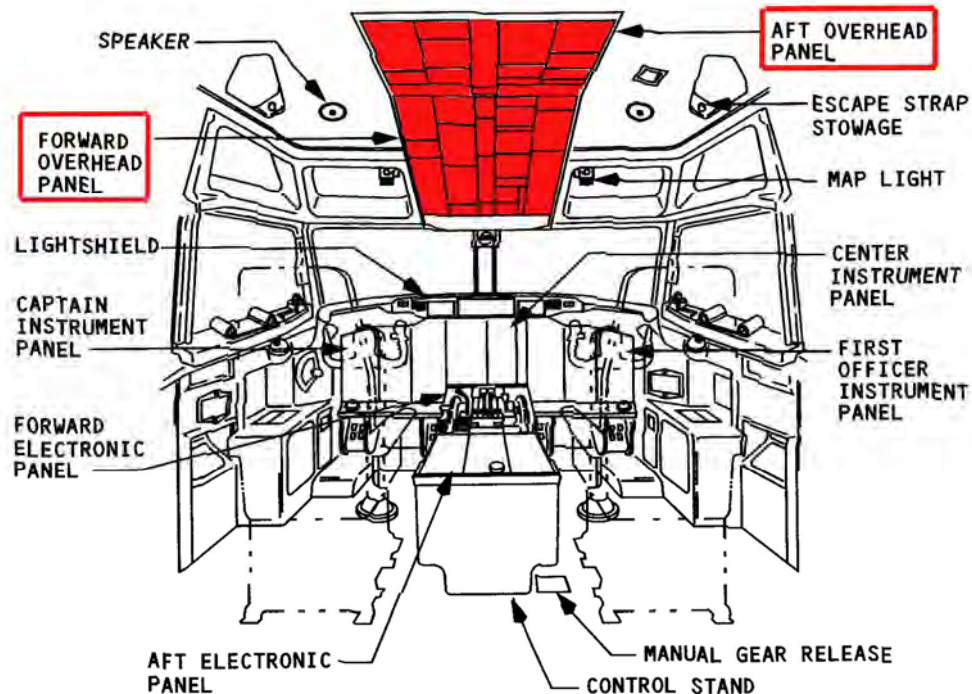
**Diagram – Position of overhead P5 panel (marked in red)**

The forward overhead P5 panel was located in the area of the cockpit within the wreckage at the accident site. The panel was accessed by removing the surrounding wreckage. Once the panel was located, low air pressure was used to remove the accumulated dirt, dust and light debris in order to visually examine the controls. The entire P5 panel was photographed and the position of the controls (toggle switches, selectors, switches, and indicators) were visually examined and documented. The controls were not activated.

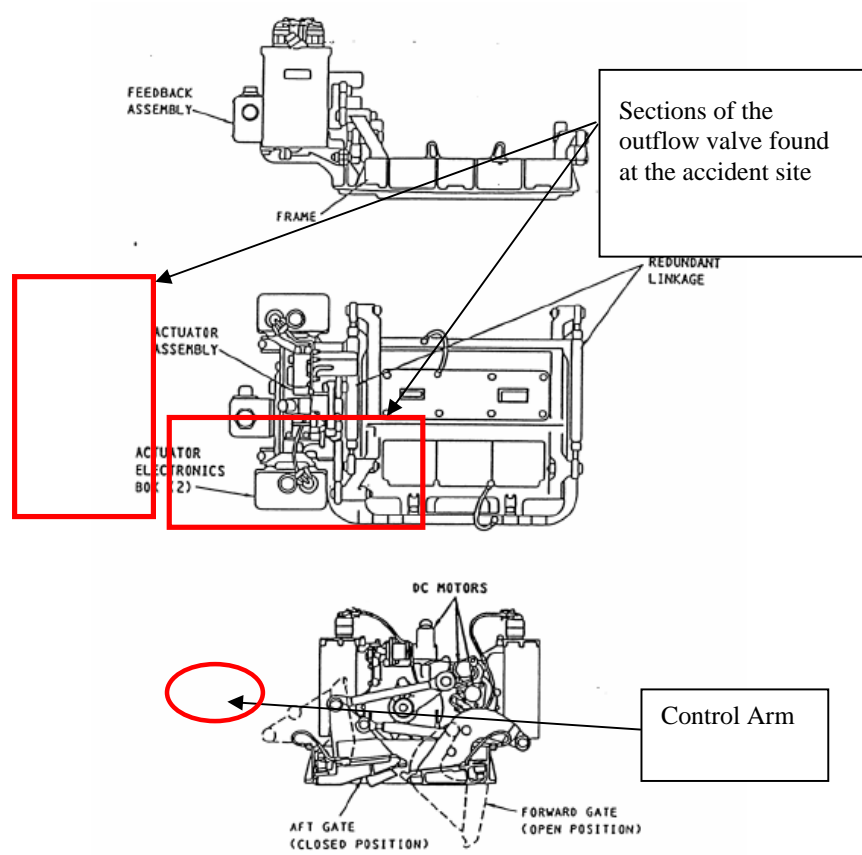
**Diagram - Aft Outflow Valve**

The actuator/motor assembly and both the forward and aft door gates of the aft outflow valve (AOV) were found at the accident site (see diagram and photos below and next page). The actuator/motor assembly was separated from each of the door gates. The condition of the actuator/motor assembly was documented and photographed at the accident site. The control arm and position indicator remained attached to the motor assembly. Using hand pressure, a small force was applied to the control arm; it was physically locked in place and not able to rotate freely. At the storage facility, a measurement was taken between the closed position stop and the control arm position lever; the distance between the two was 8.0 mm (see photo in the next page).

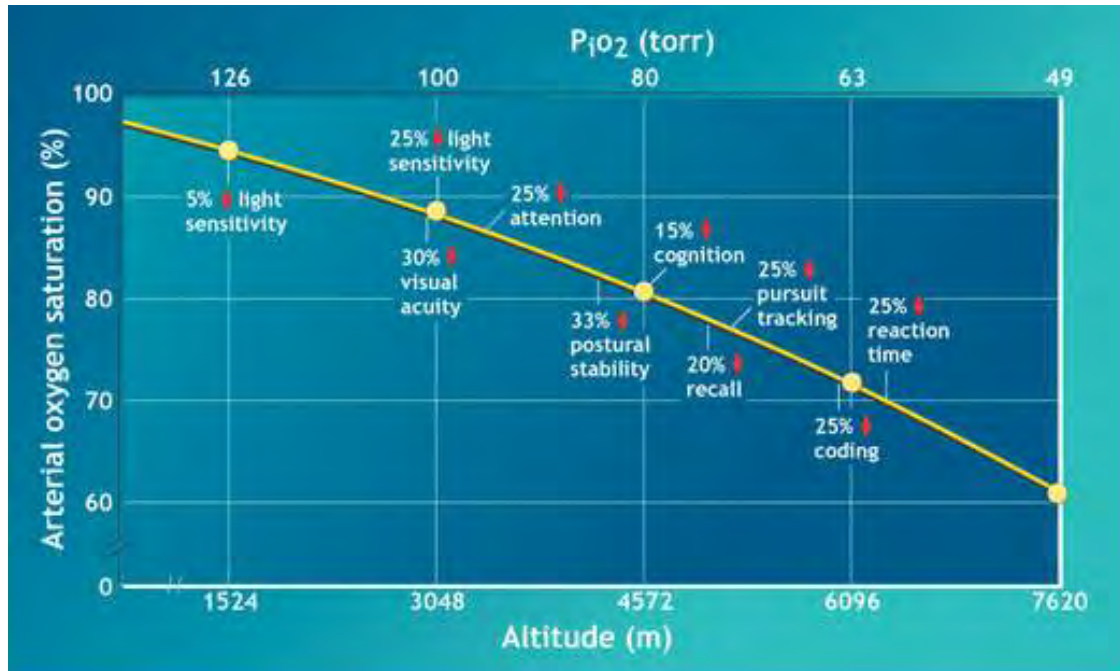
**Diagram - Haemoglobin Oxygen Saturation and Performance (McArdle, 2001)**

The decrease in  $SaO_2$  leads to both physical and mental performance degradation. In aircraft operations, where muscle work is not the major requirement, the decrements in mental capabilities are most important for the flight crew in relation to safe aircraft guidance. The diagram of Haemoglobin Oxygen Saturation and Performance shows a collection of corresponding findings.
